# SOUTH SHIELDS: SOUTH MARINE PARK BANDSTAND RESTORATION

**South Shields: South Marine Park Bandstand Restoration**

An example of a design and build project undertaken by Lost Art Limited and completed within the allocated budget.

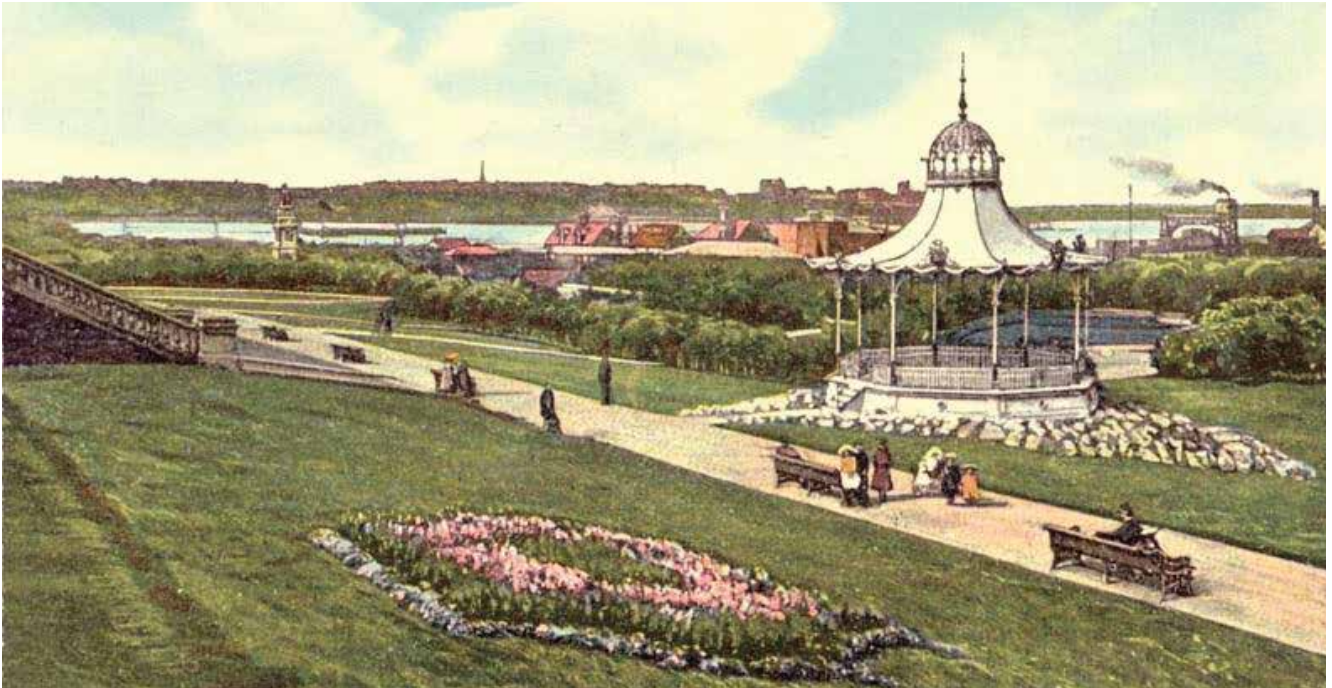
At the time of the commission all that was available to Lost Art were a series of images, mainly old postcards, showing the old bandstand.

Using the historical images as the starting point for our research, the original bandstand was identified as having been produced by the MacFarlane Company of Glasgow who operated from the Saracen Foundry and were significant producers of architectural ironwork including bandstands.

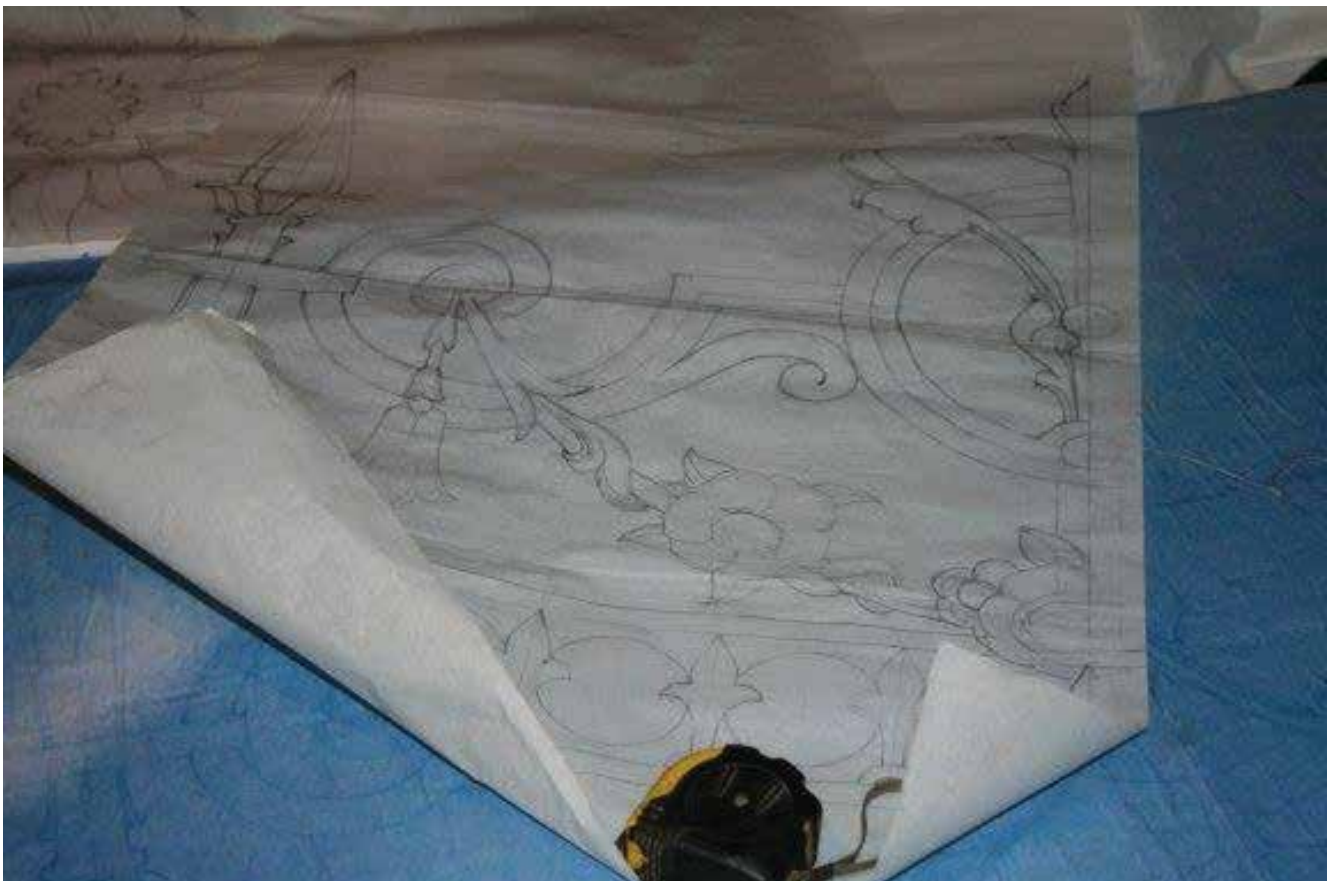
The first stage of this is to produce working scaled drawings from the catalogue images.

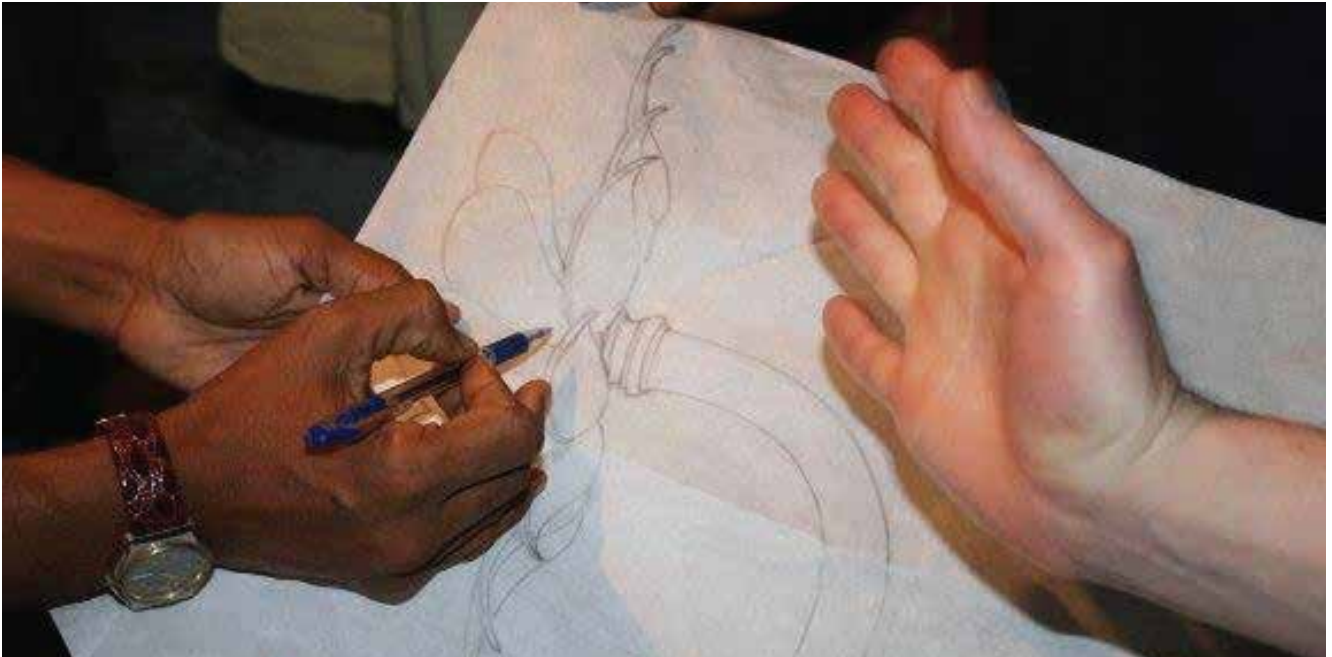
The image above shows the back section of the sunflower detail whilst the following image shows two carved sections of the flower together, as they would be assembled on the bandstand itself.

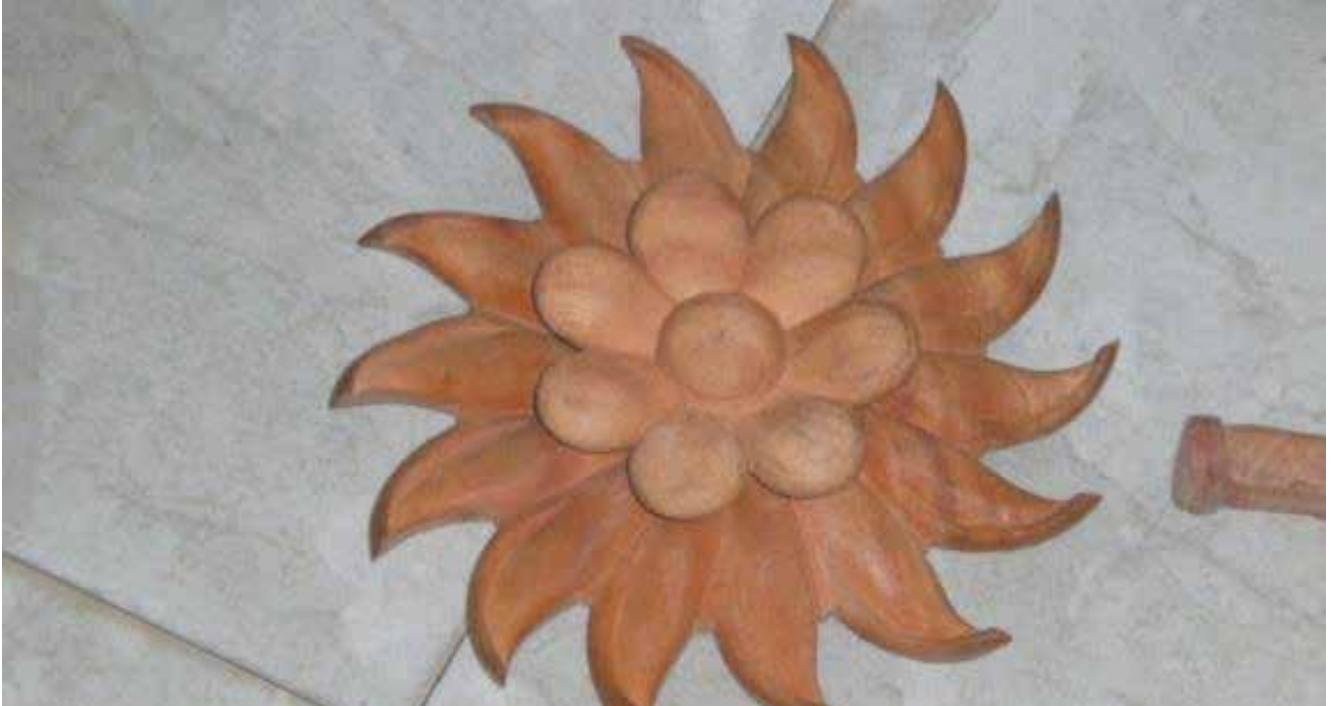
A further component of the sunflower feature is the 'stalk' which was also carved.

Having produced carvings of all three sections of the sunflower roof detail, these were then passed to the pattern maker in order that the actual foundry casting pattern could be produced.

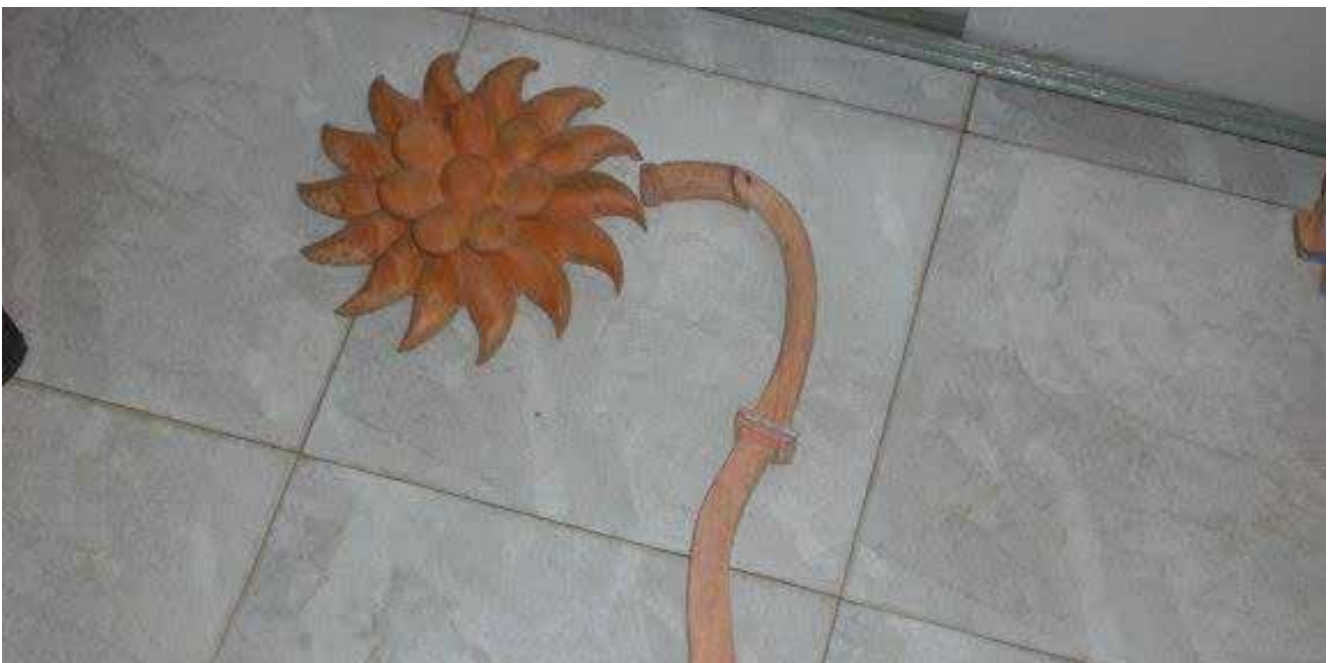
Other components, such as the panel from the roof of the bandstand was also produced in wood.

As the work progressed, with the drawings overlaid onto the wood and carved through, they were repeatedly checked for accuracy until a final positive carving was completed, such as that shown below.

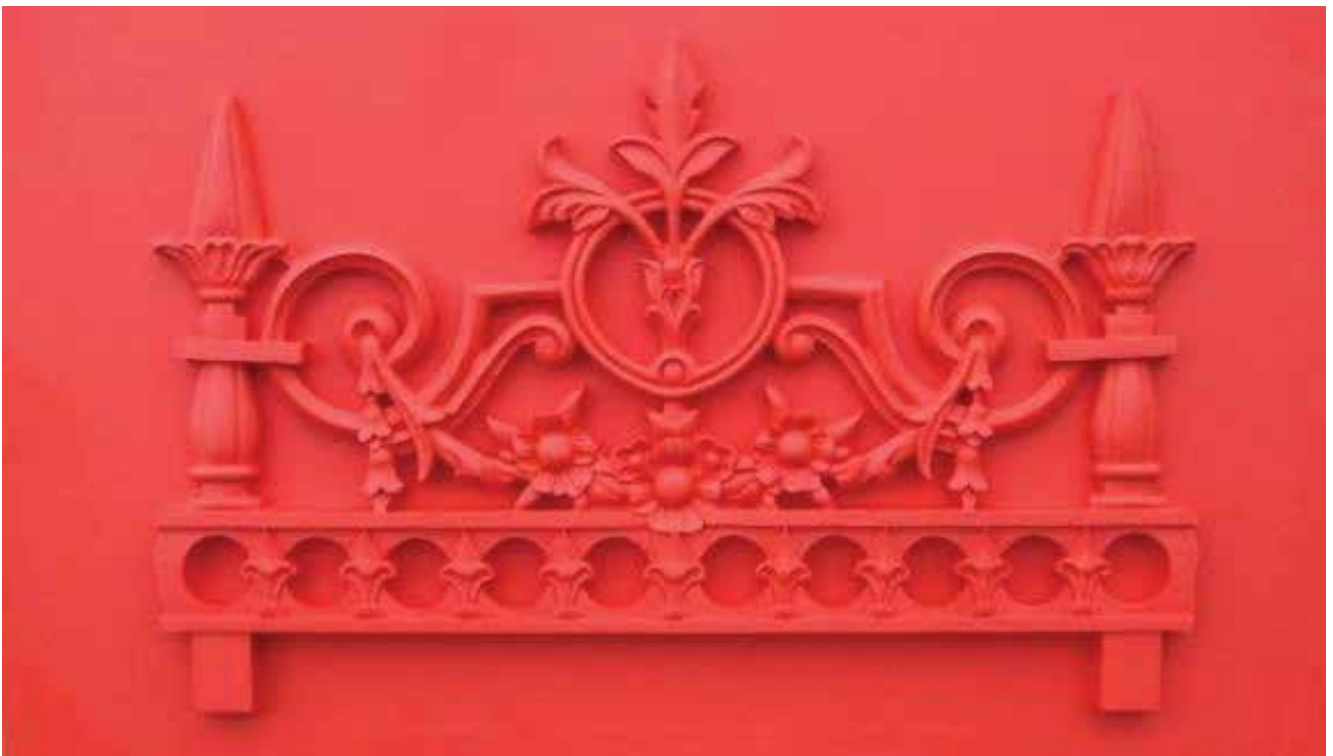
As the carvings were produced and passed on to the pattern maker, he was then able to construct the moulds from which the foundry would create the cast components

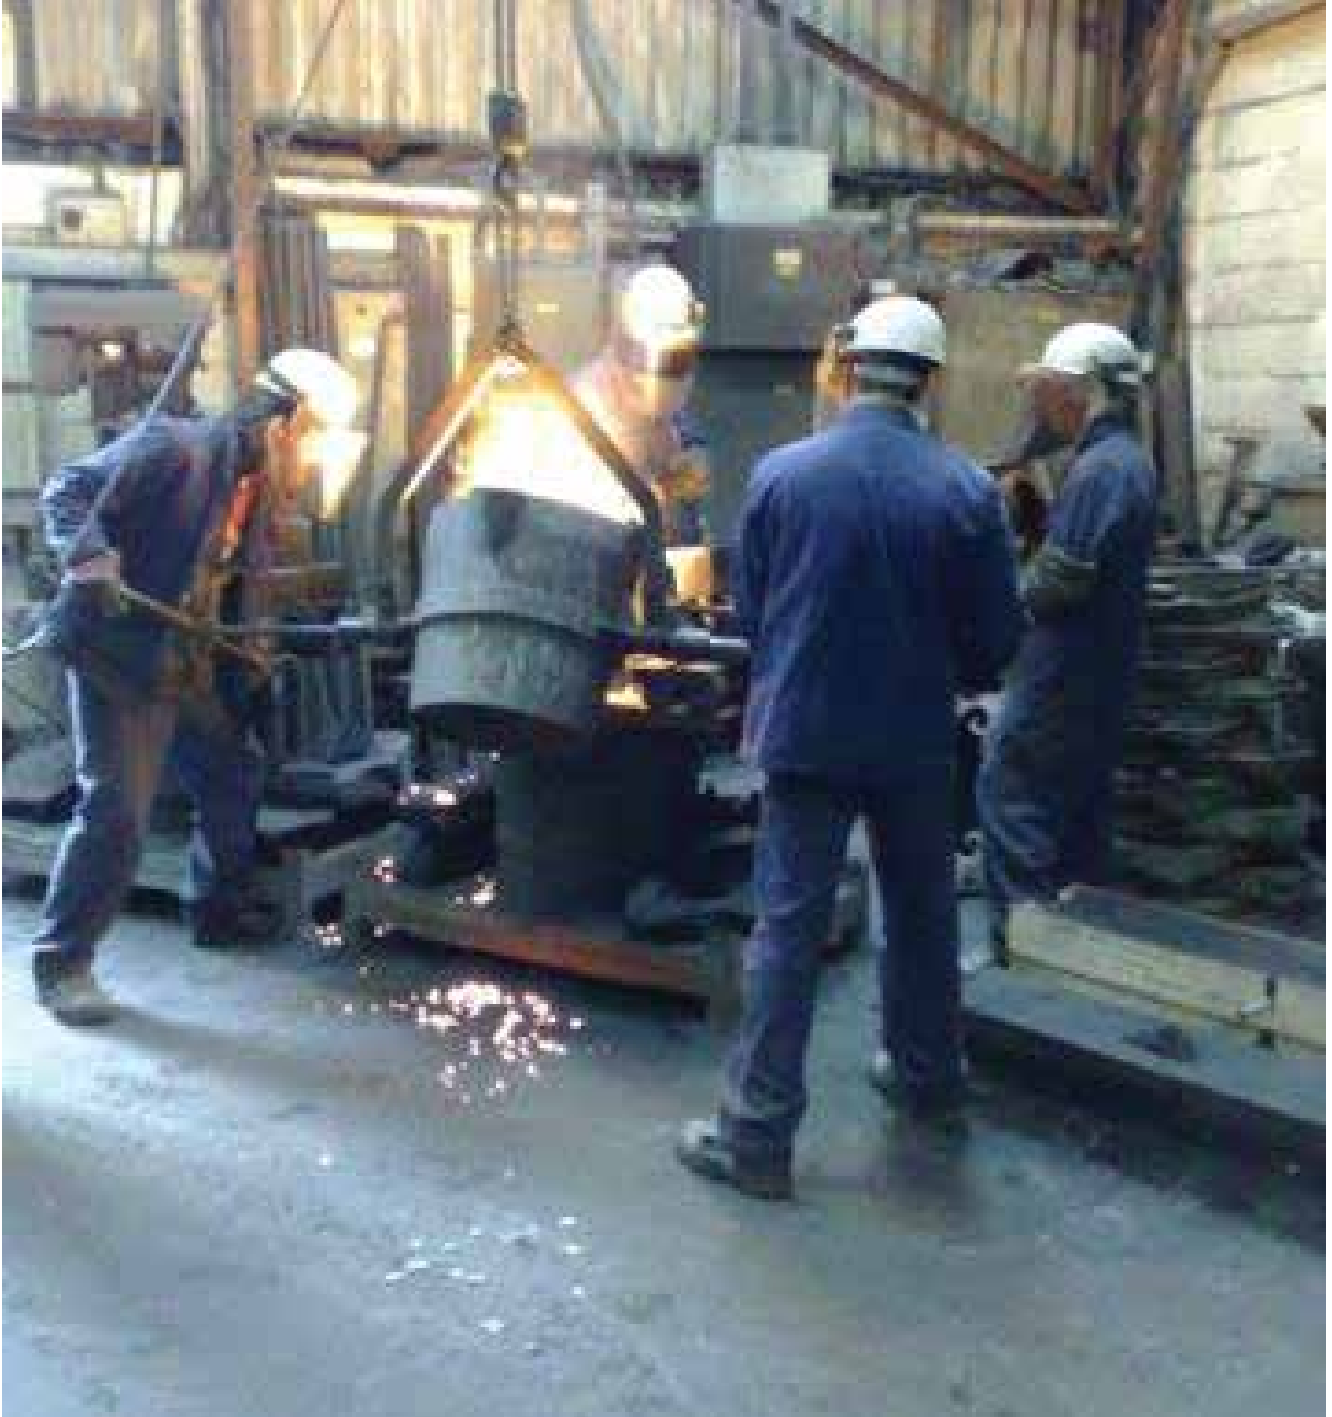
The patterns are set on wooden boards and are used to make a mould in sand into which the foundry workers pour the molten iron.

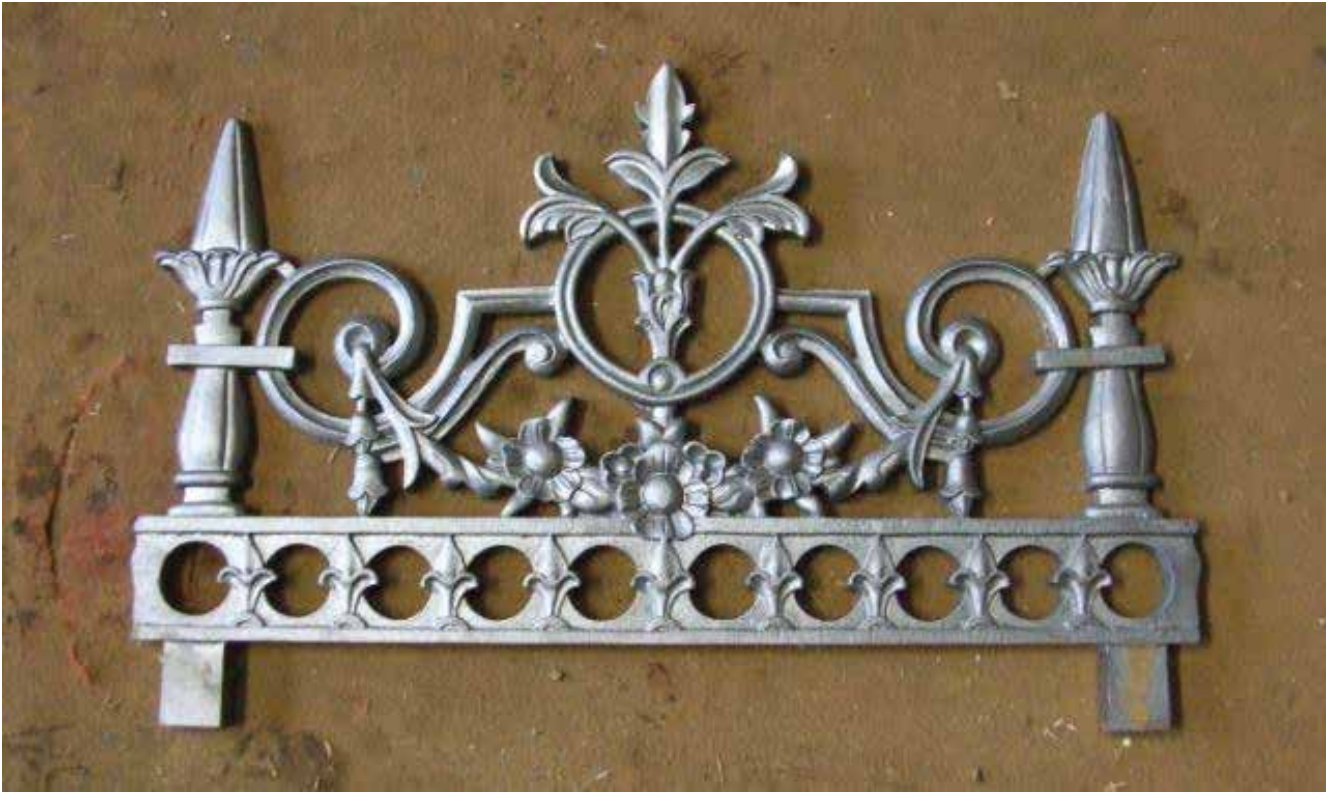
Following the casting process, the components are first shot blasted to remove the roughness from the surface of the metal and then fettled to remove any excess iron remaining from the casting. Having used high quality patterns and an experienced craft foundry, what remains is a crisp clean casting demonstrating a lot of clear detail.

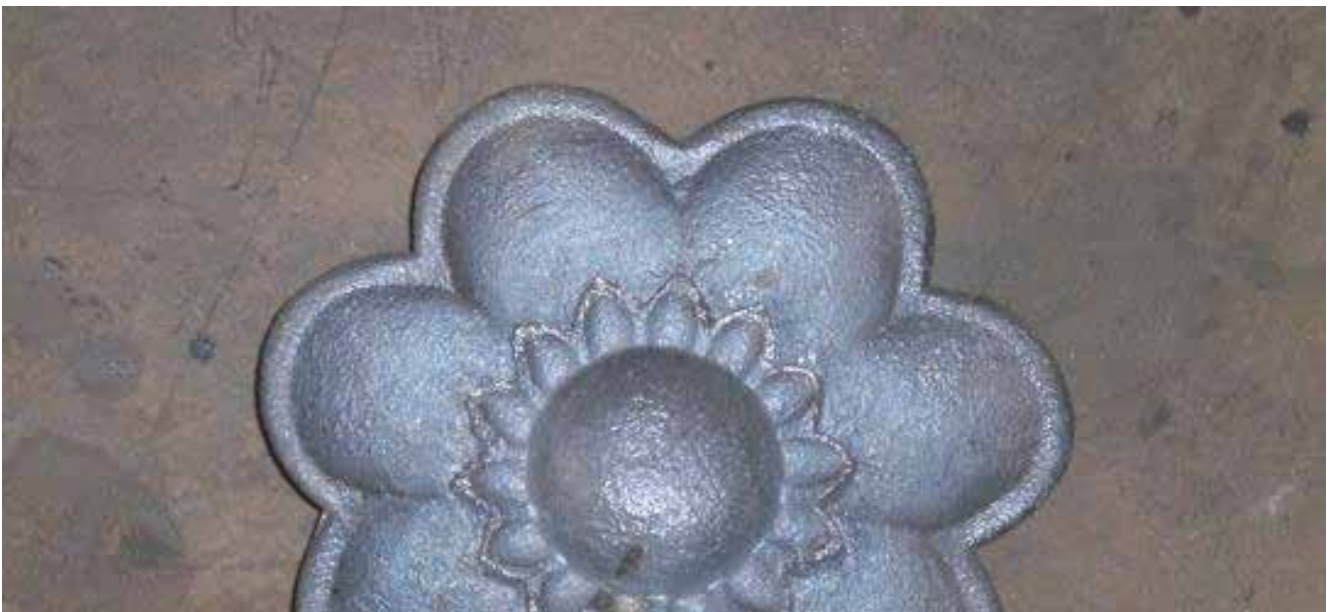
A variety of components were first cast in iron, with each part then being electroplated. This process offers significant protection against corrosion (primarily rusting) but because of the thinness of the chemical coating allows much more of the detail and fineness of the casting to be viewed when compared to the alternative process of galvanising.

The following images show a variety of components that have first been cast then electroplated.

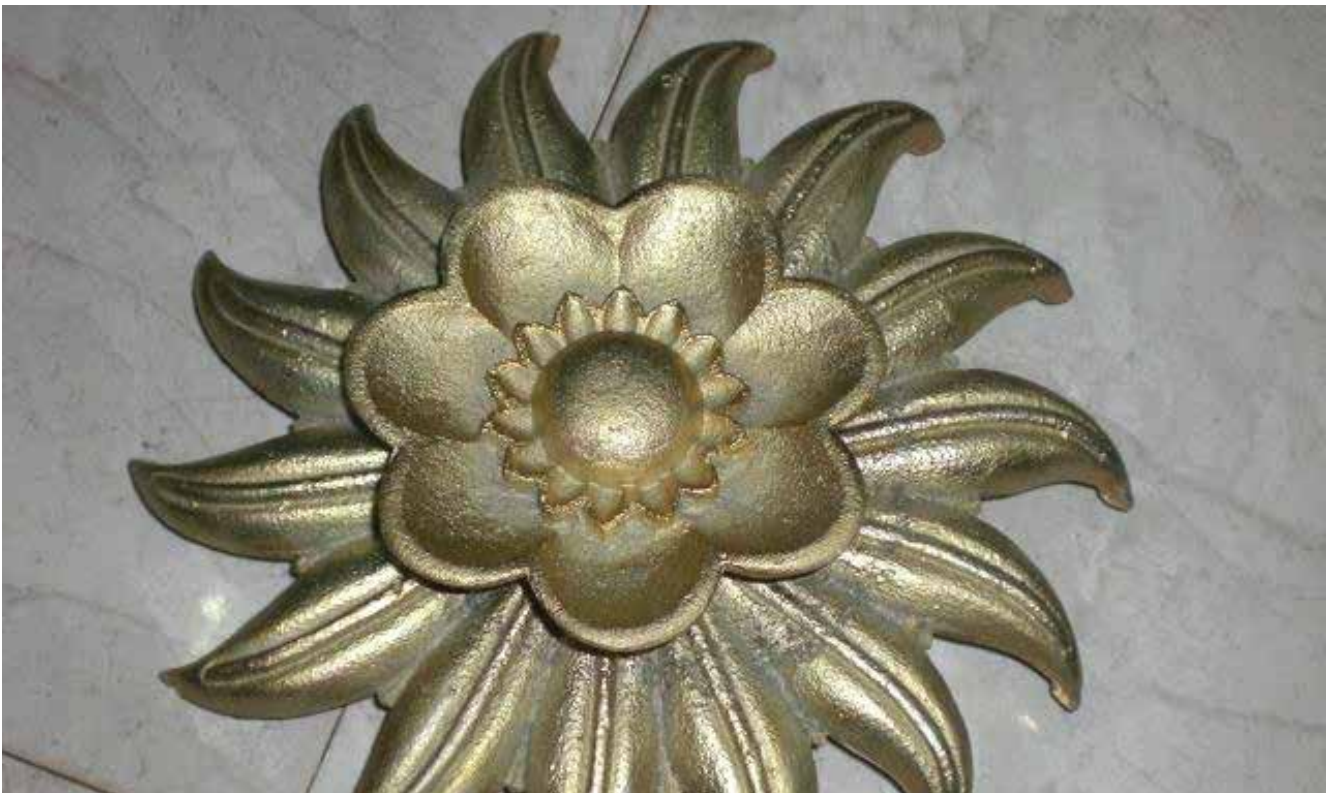
Components were also combined as for the final versions for the construction of the bandstand.

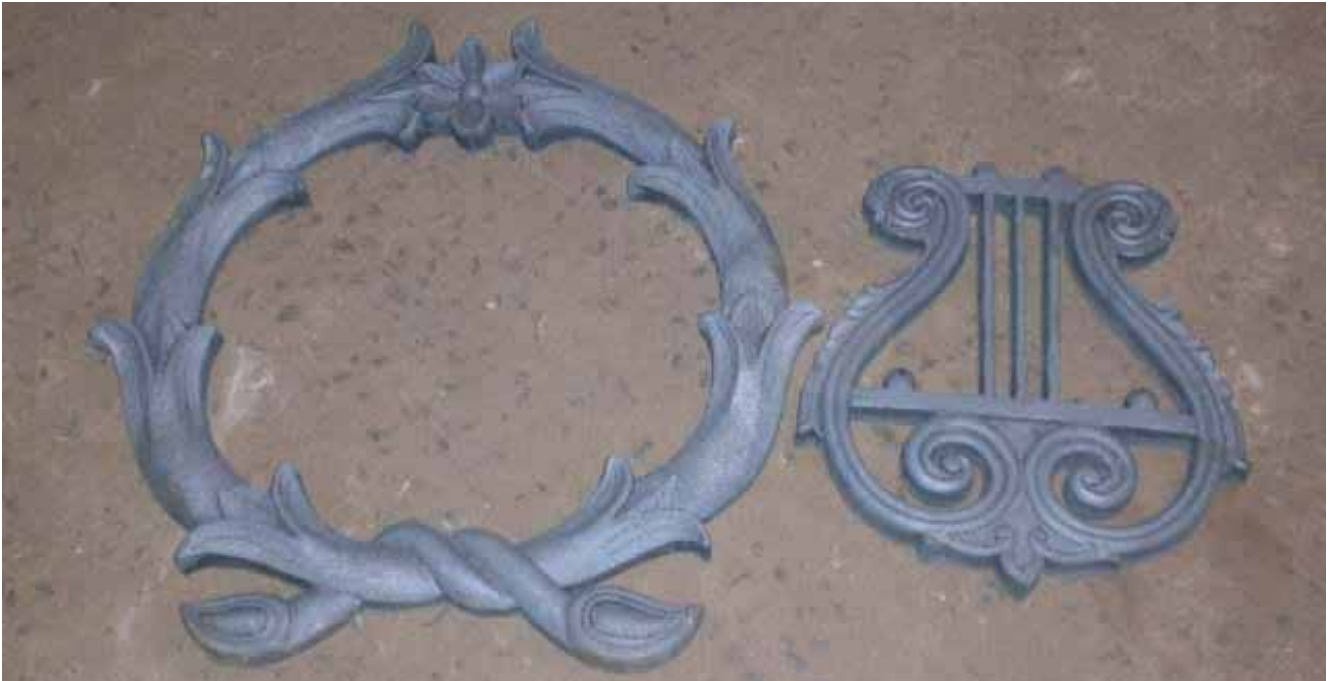
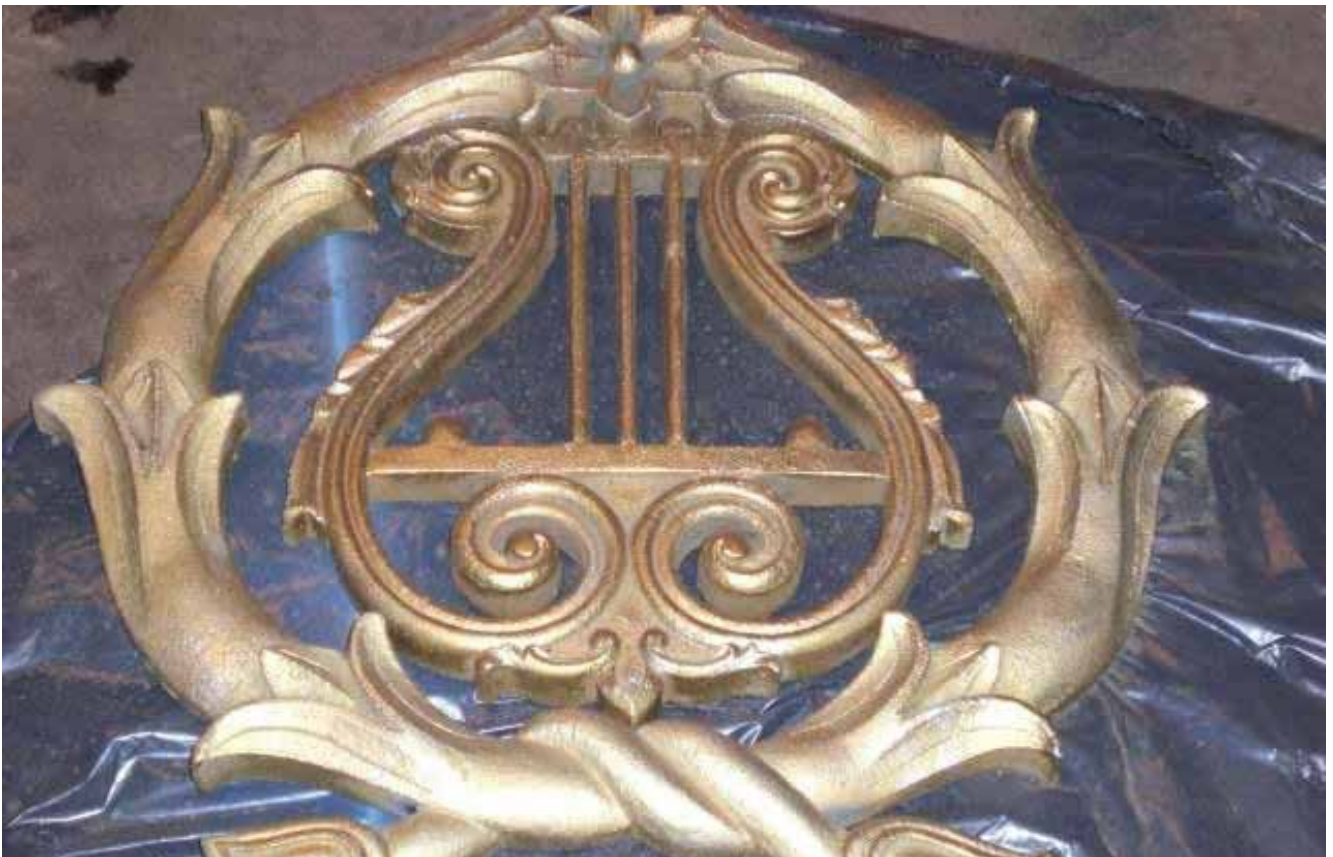
## The laurel wreath and lyre

These two components are produced individually and then combined into the item shown on the historic photographs where they form a decorative element to the panels surrounding the bandstand.

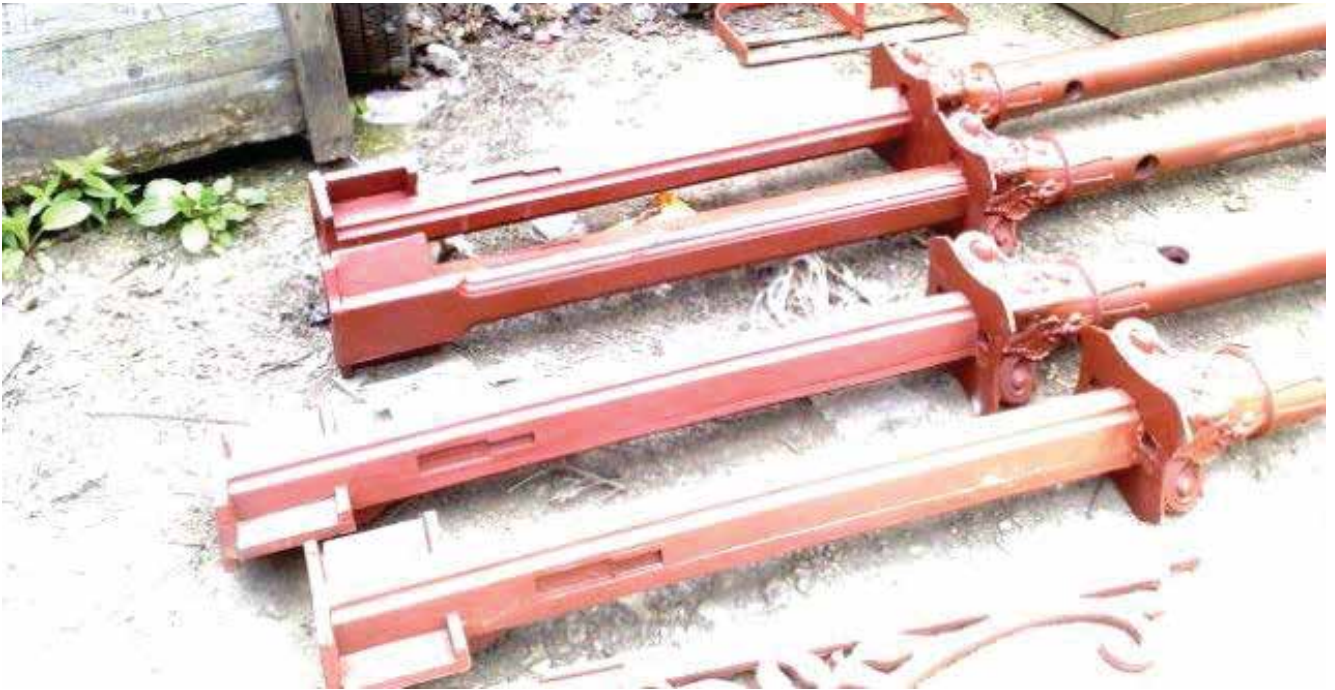
In addition to the casting and plating of the smaller components, some of the larger components had also been cast and primed:

These include the support columns:

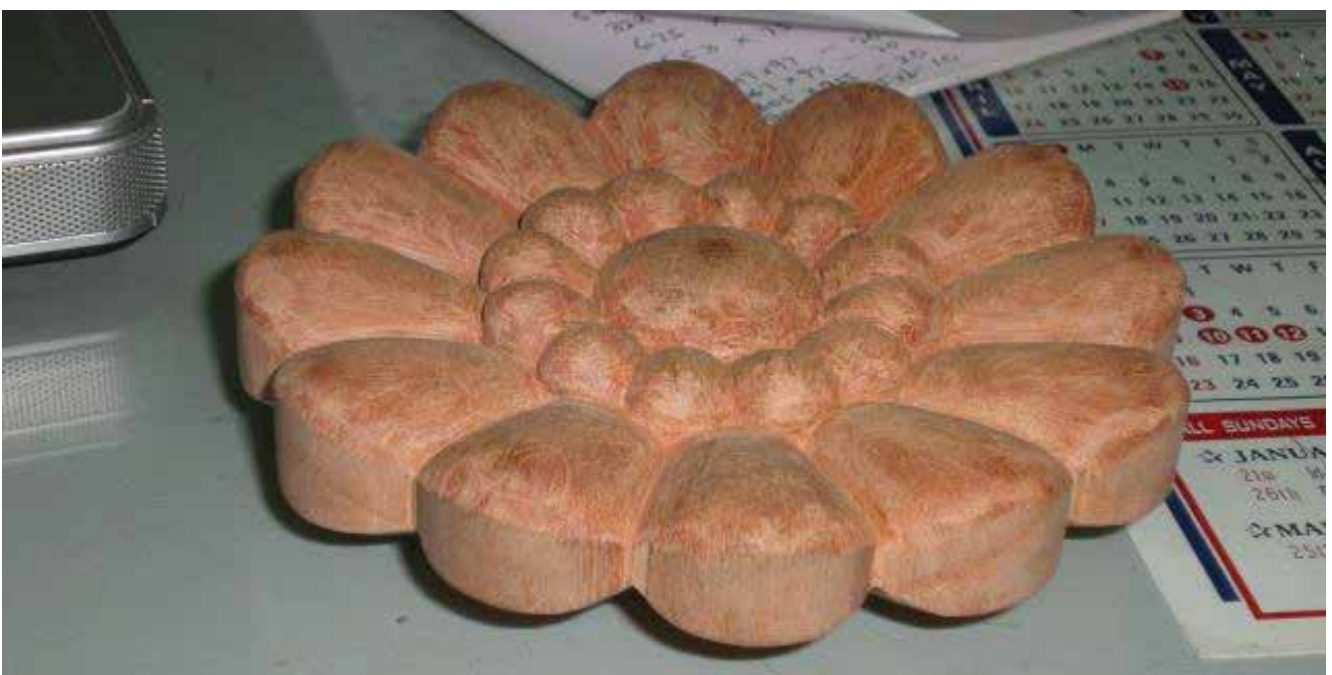
The flower detail for the lower railing:

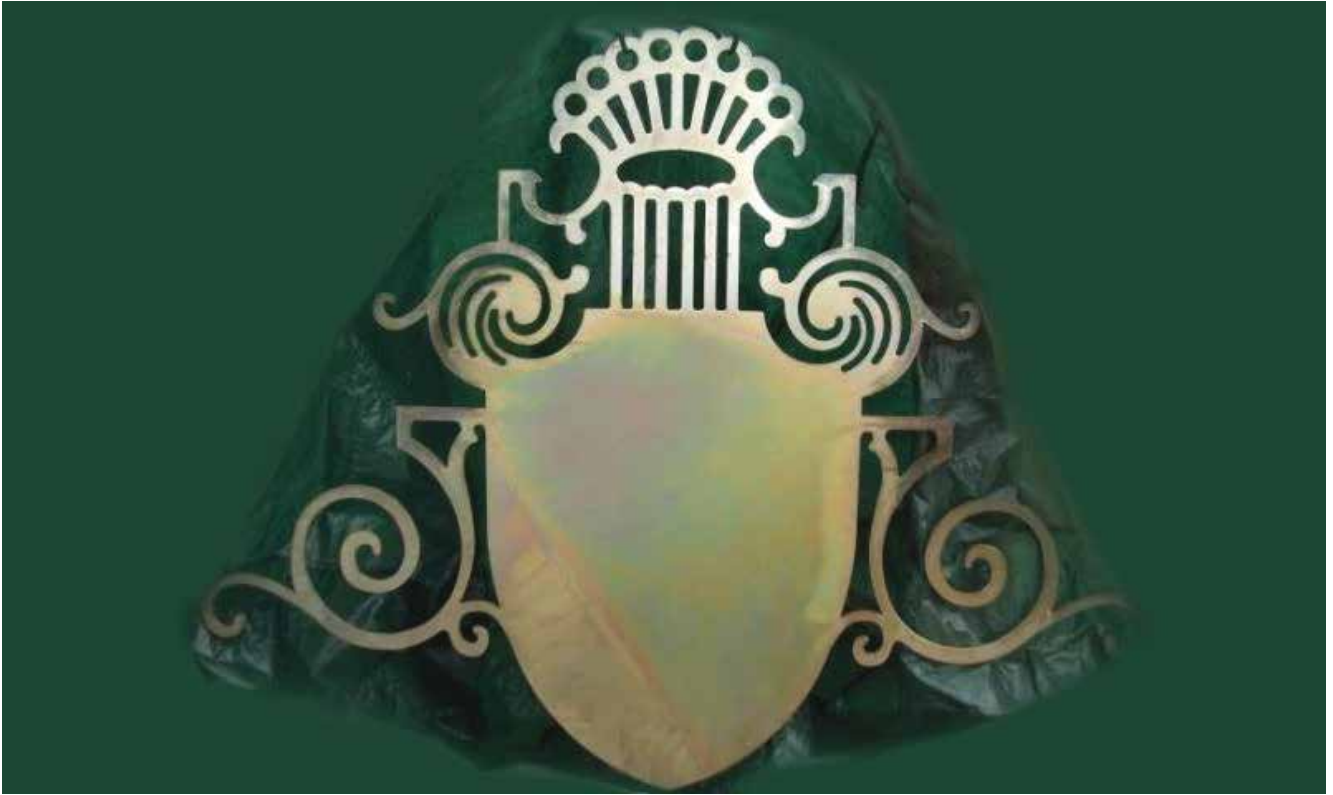
Shield Backplate

The back plates of the shields themselves were produced separately and the shield decorative detail carved prior to casting the details. Further research helped identify the flowers shown on the decoration as passion flowers. These were then carved prior to casting of the detail for application to the shield backplate.

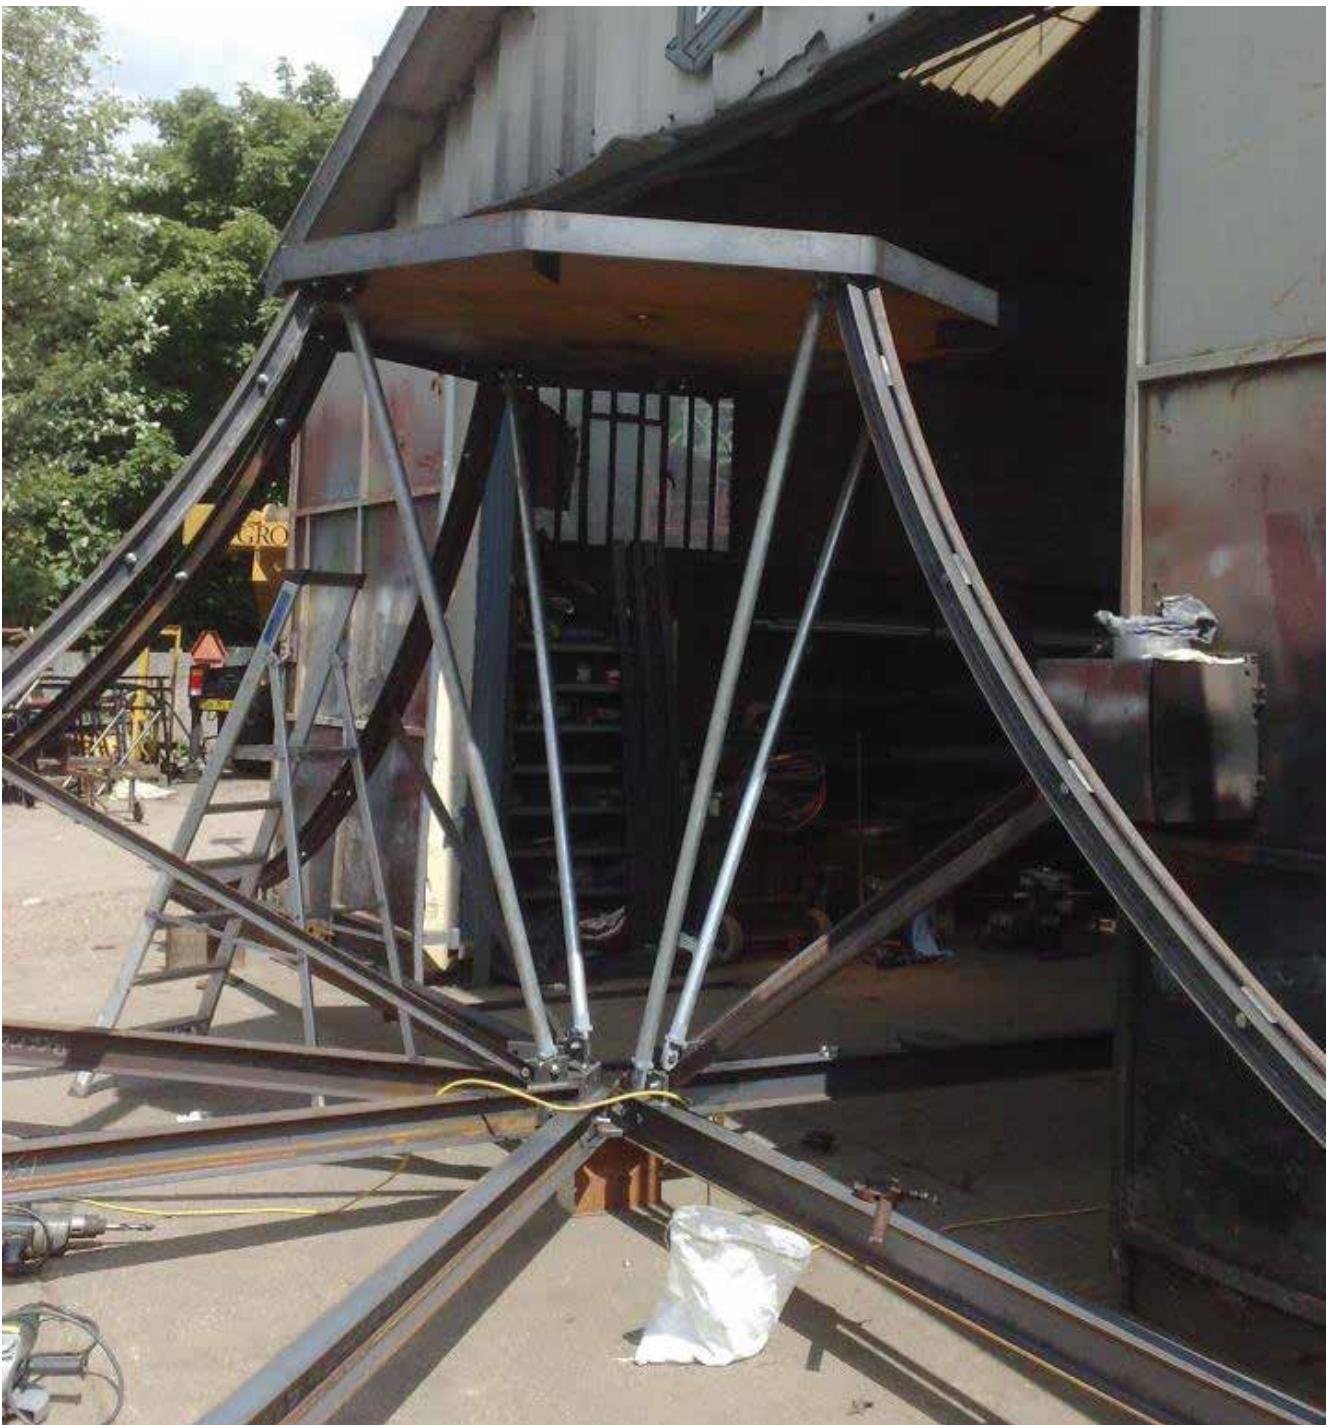
The crowning glory of any bandstand is usually the roof. This was particularly true of the South Shields bandstand. In addition to the usual sloping zinc covered roof, there was the added feature of a wrought iron cupola, also featuring cast iron decorative elements.

Following the production of scaled engineering drawings of the roof, individual components of the roof structure were produced and test assembled.

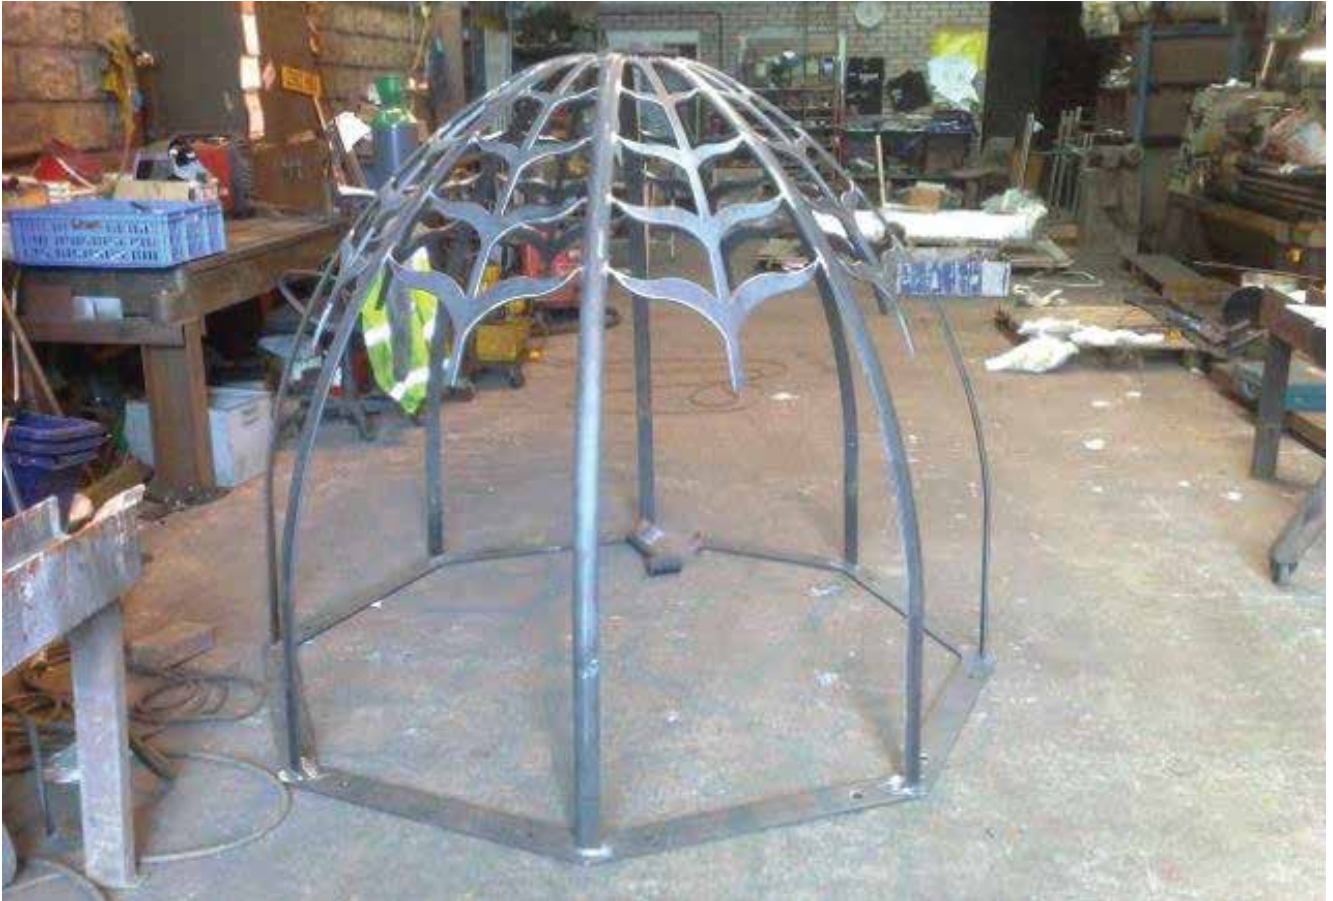
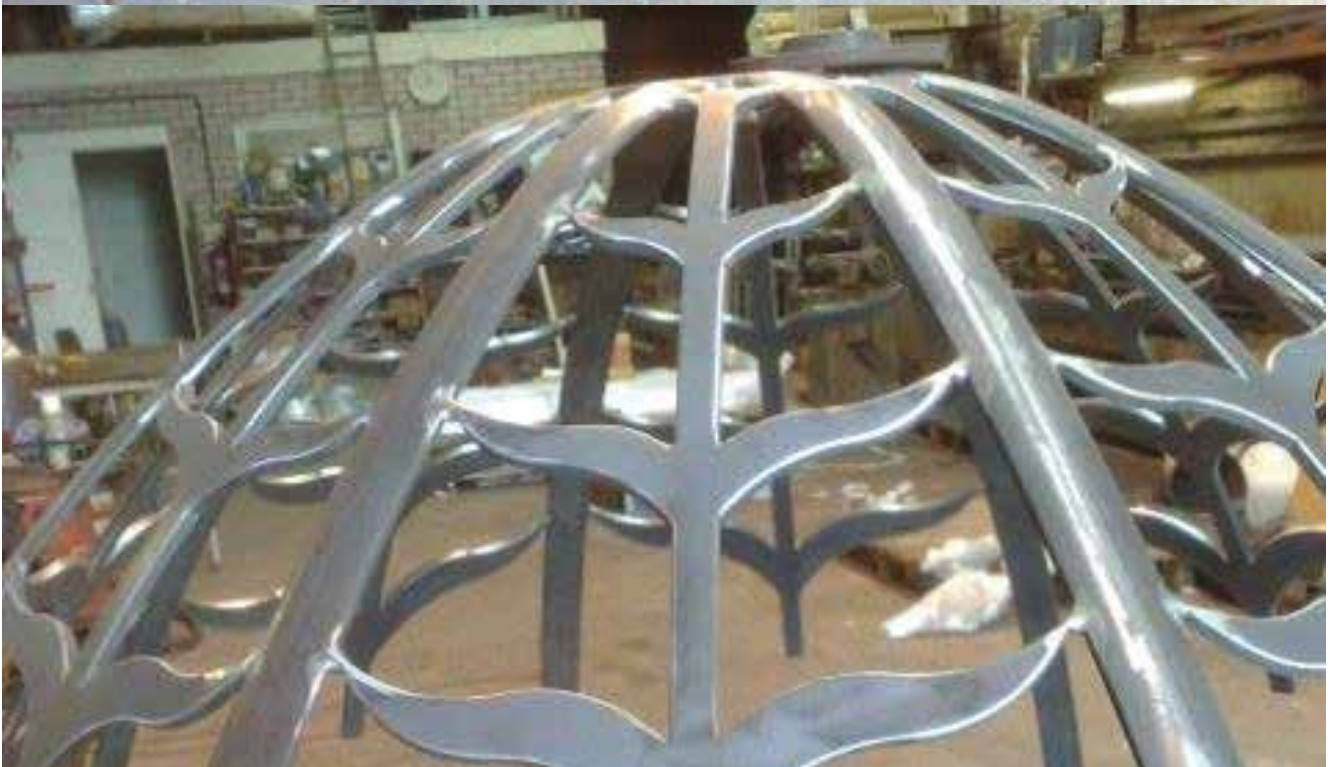
The production of the roof cupola continued, with significant progress having been made on the inclusion of the wrought iron decorative elements.

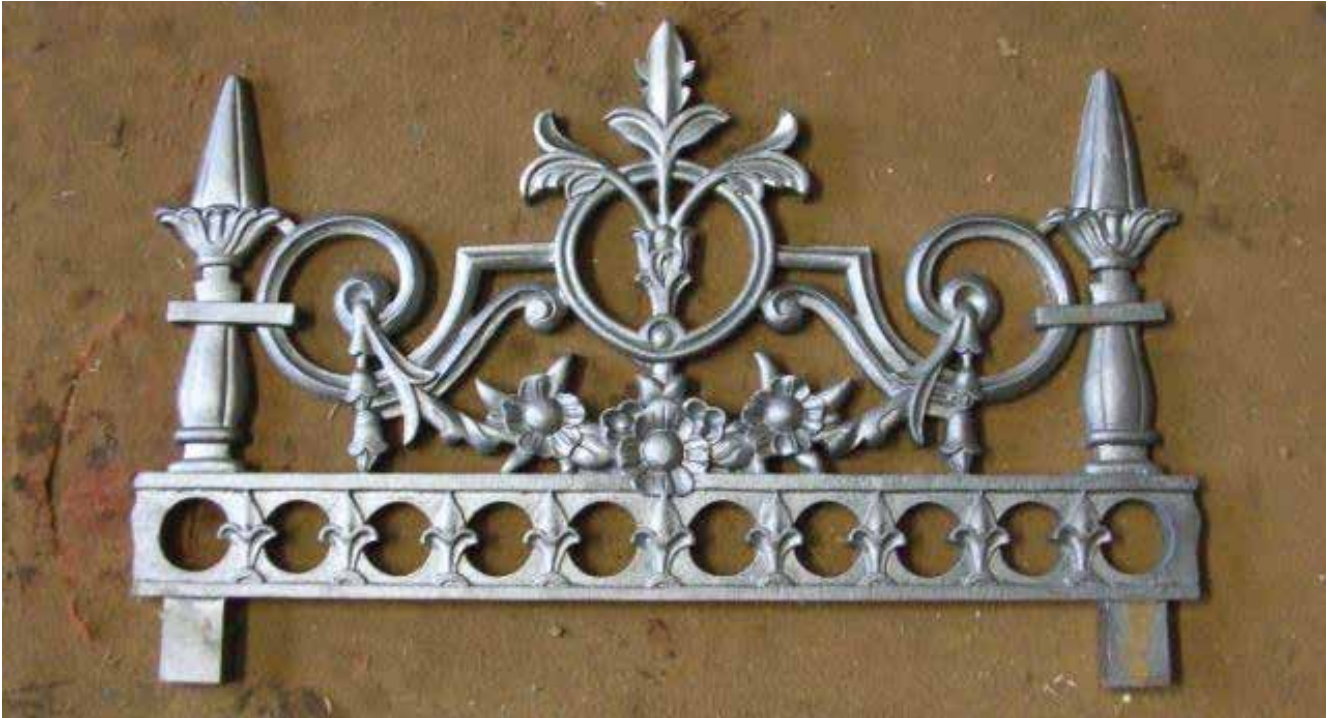
The lower part of the cupola incorporates a small section cast iron panel. As previously described, this was identified within the archive MacFarlane Foundry catalogue and a pattern created to allow for new castings to be produced.

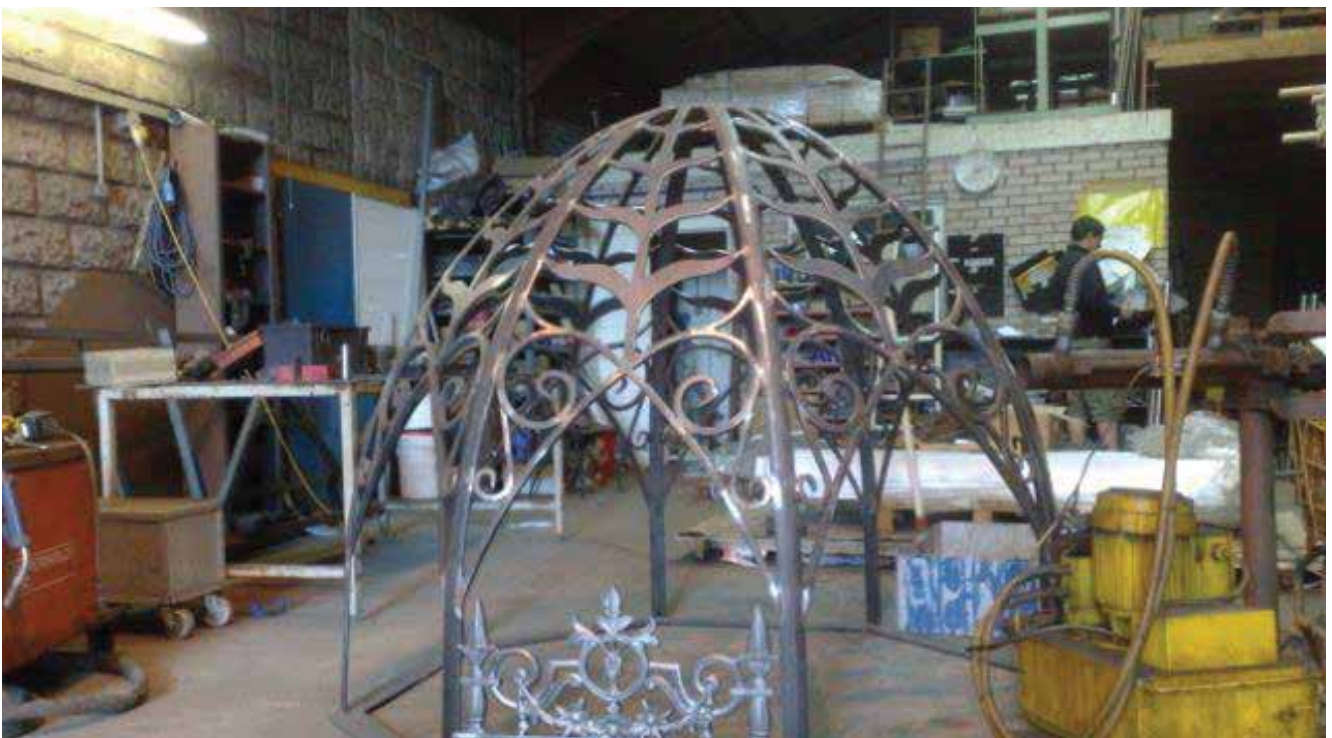
The cast panels produced were incorporated into the cupola section of the roof along with further decorative wrought ironwork.
