# SOUTH SHIELDS: SOUTH MARINE PARK BANDSTAND RESTORATION

**South Shields: South Marine Park Bandstand Restoration**

An example of a design and build project undertaken by Lost Art Limited and completed within the allocated budget.

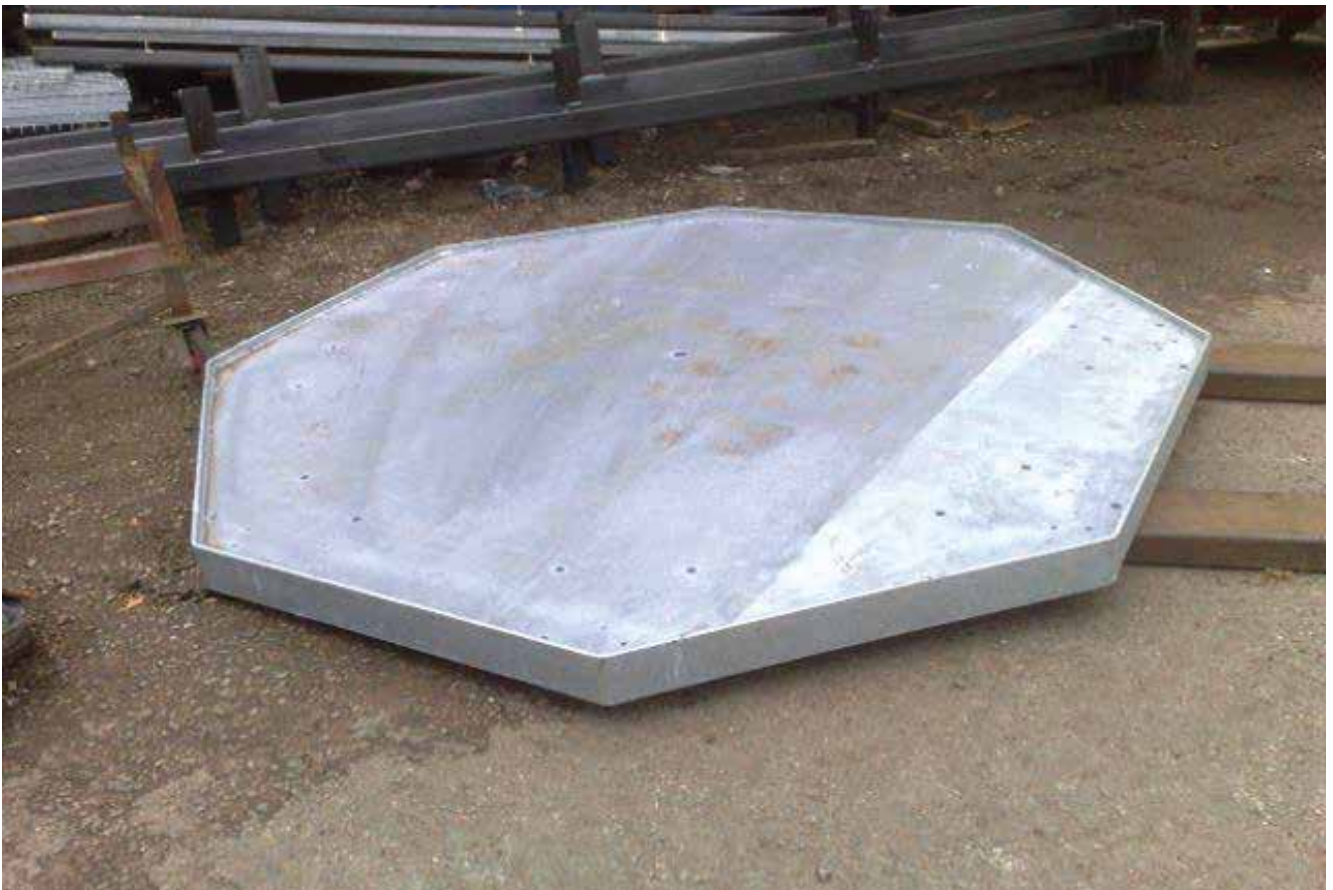
The base of the cupola was also fabricated.

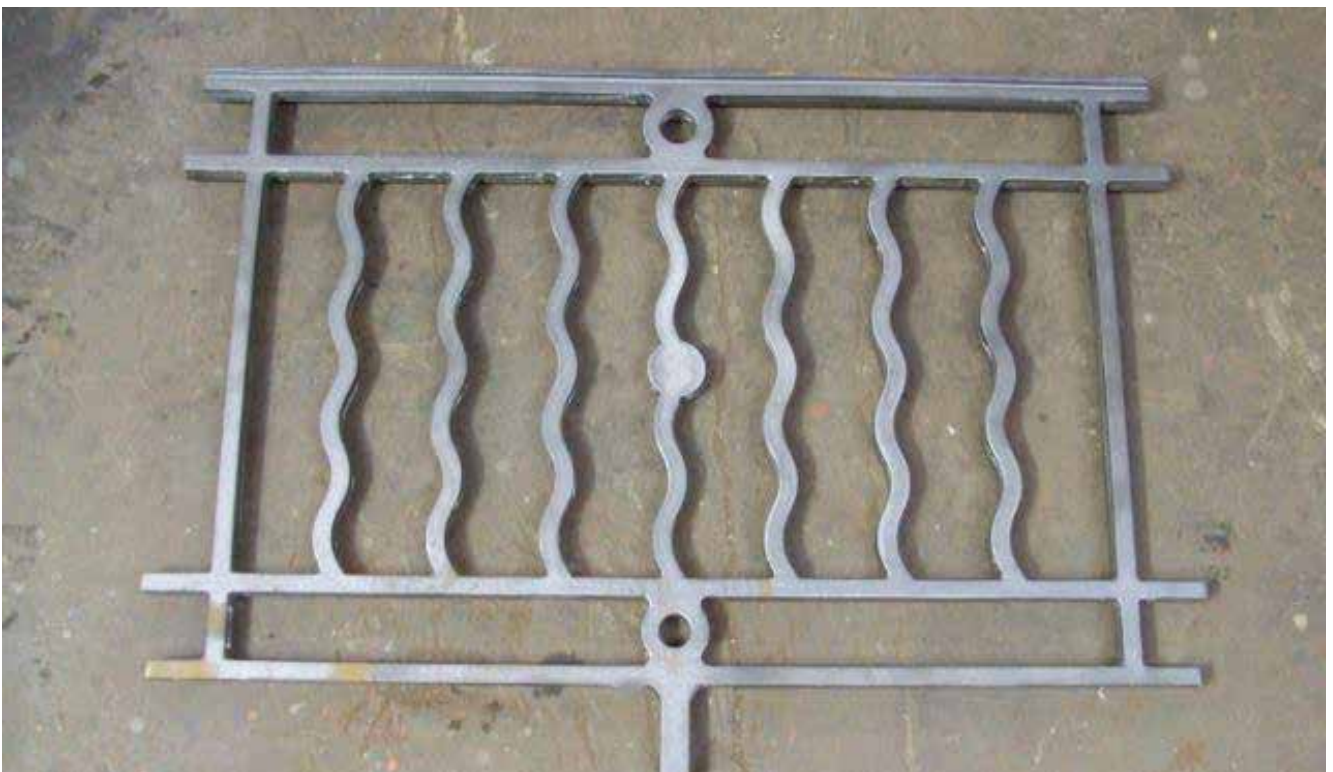
As can be seen, there are two styles of perimeter panel, this is necessary to allow the production of the full perimeter.

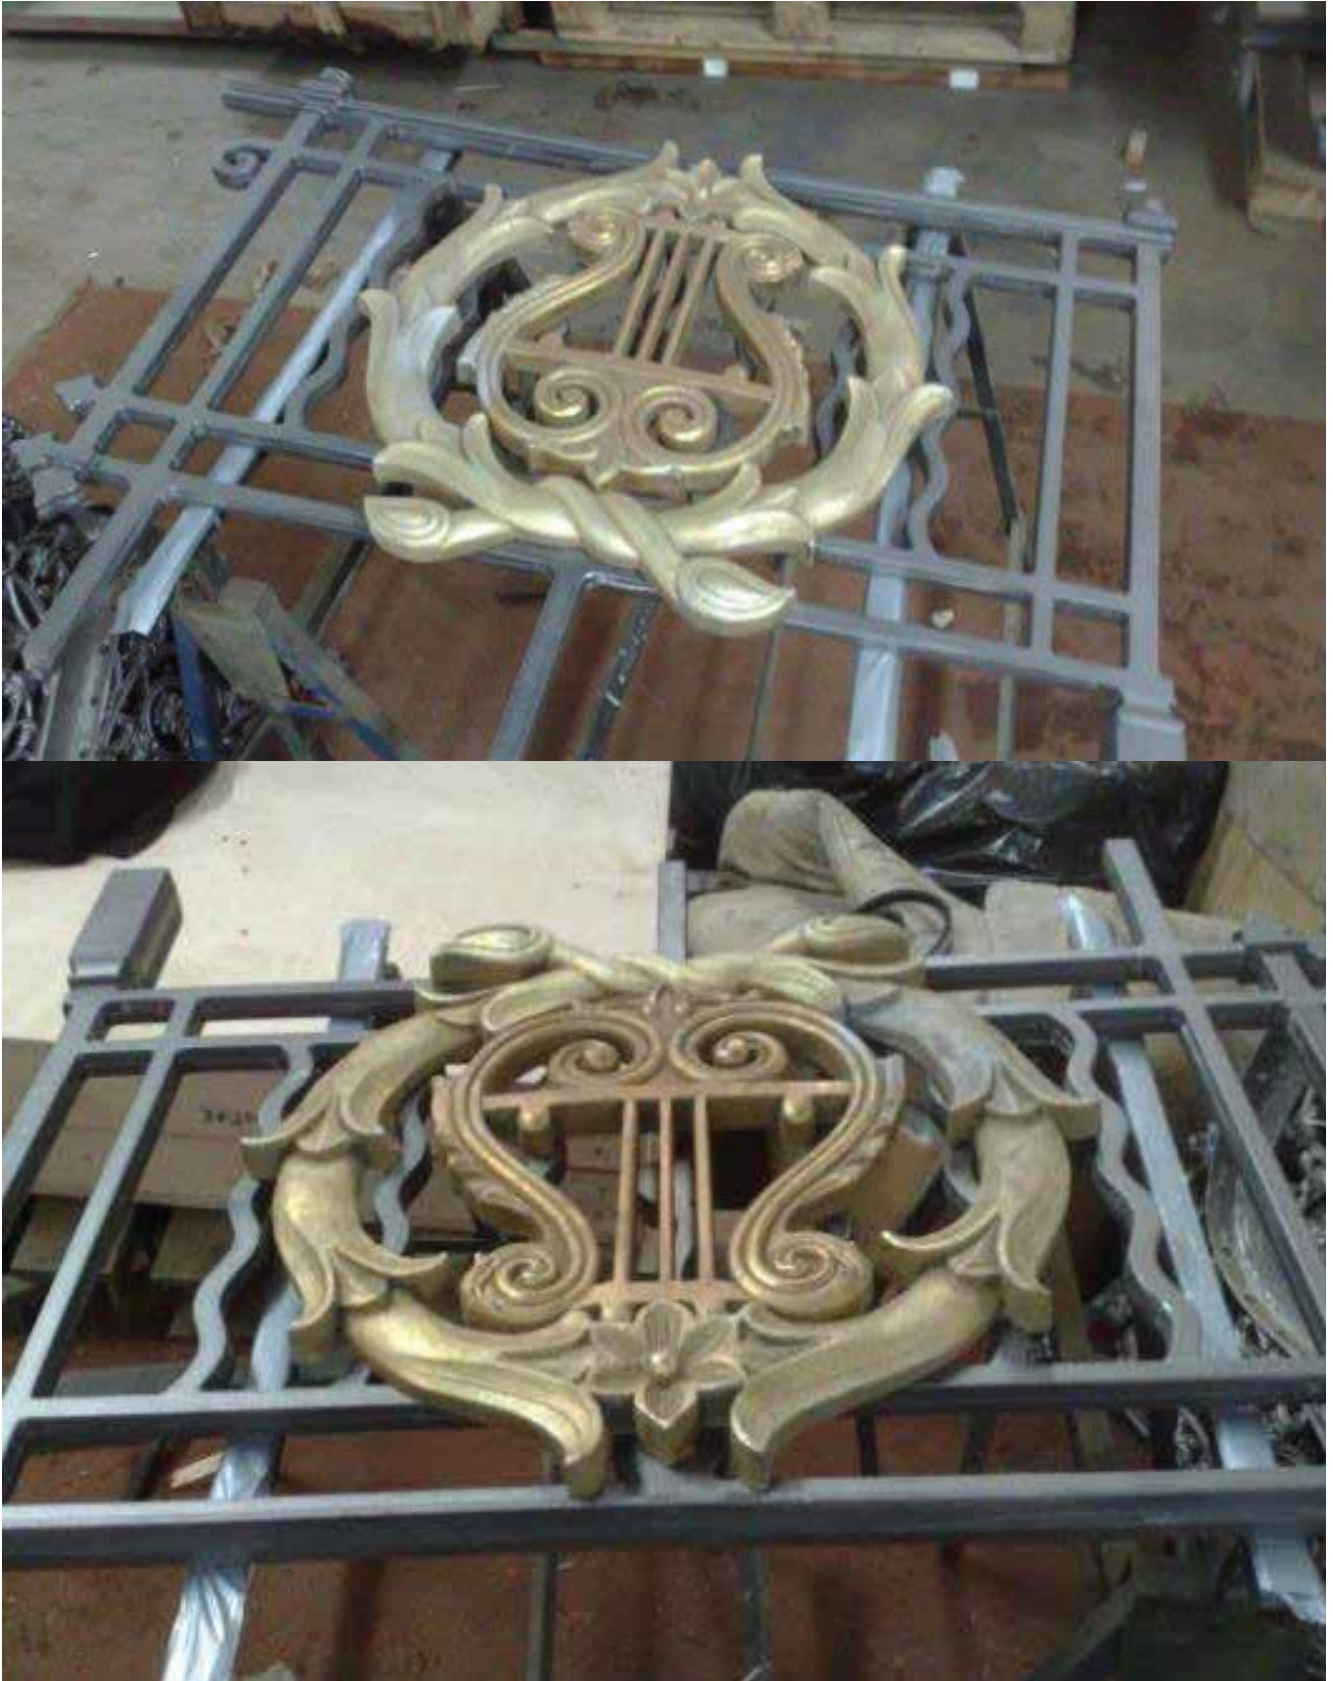
The panels were subjected to test assemblies using the other decorative components that would be added later as appropriate to each panel.

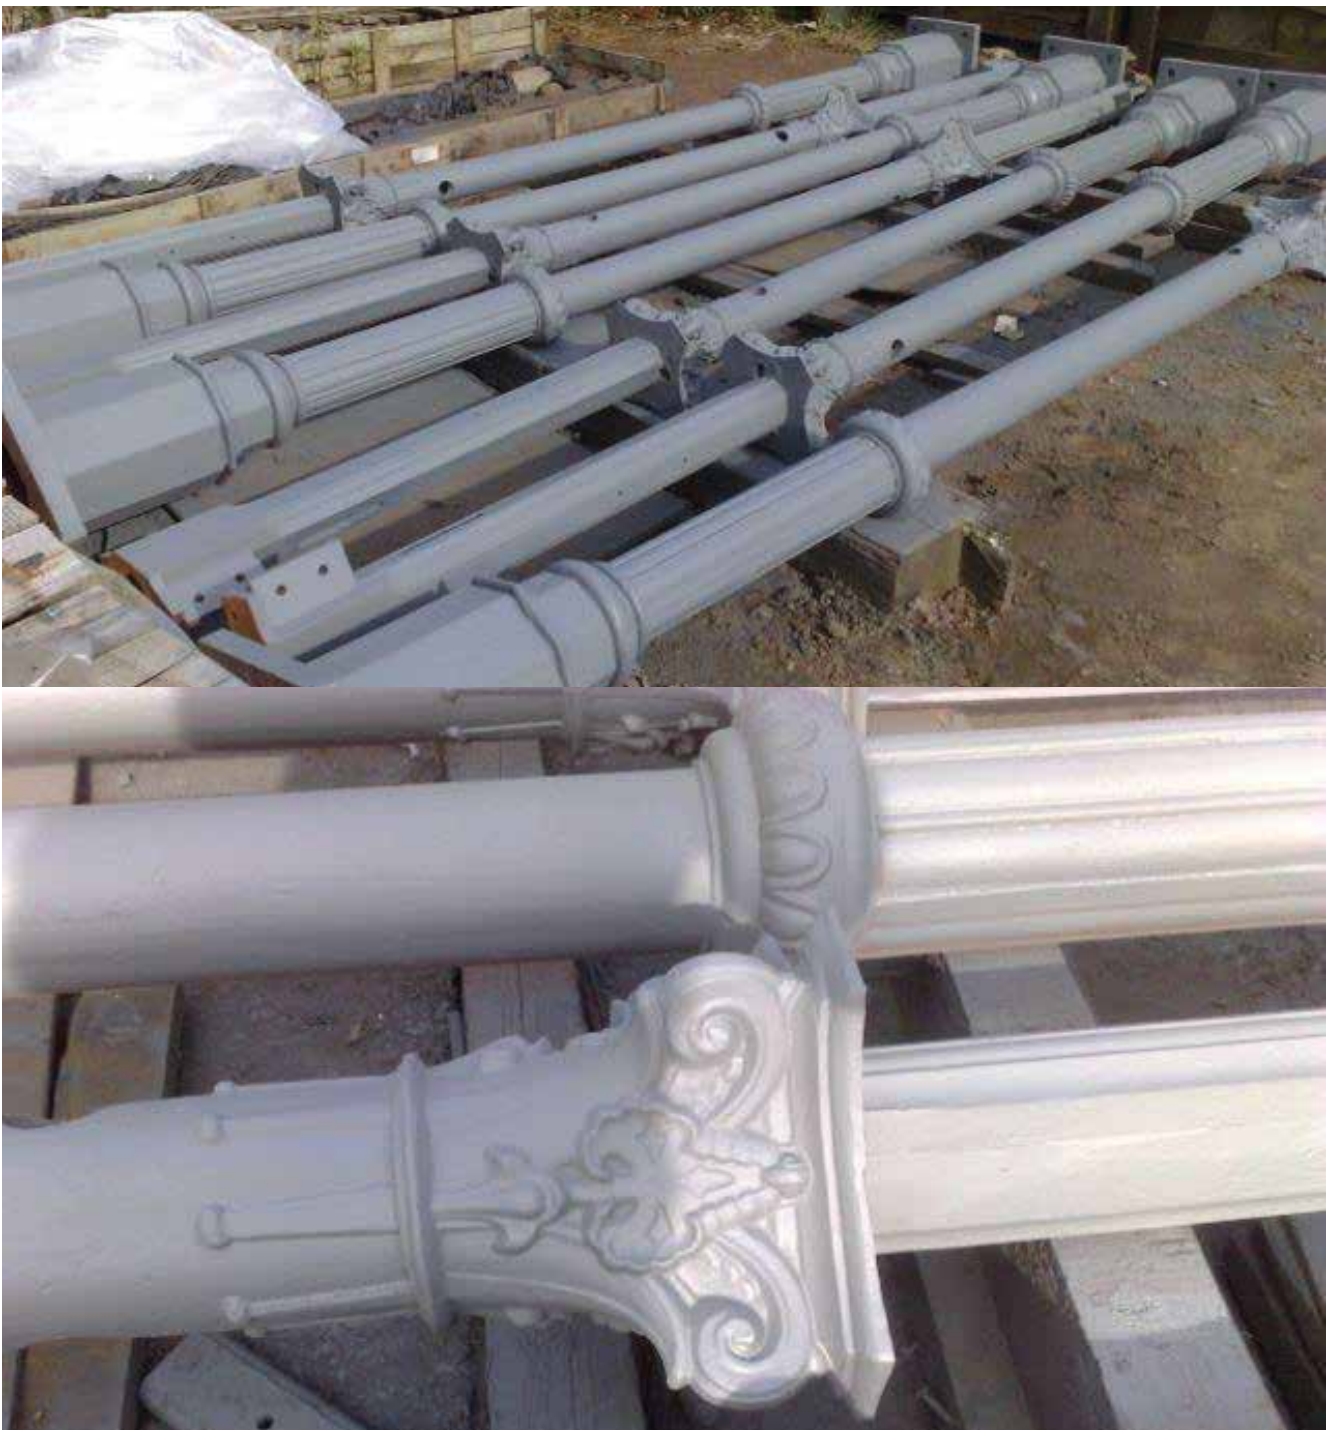
Each component has several layers of paint for maximum protection against corrosion. Here the support columns have been painted with a zinc phosphate primer.

This is a base cover of paint and is applied to the large components shown above and the smaller components shown below, in addition to these having been electroplated.

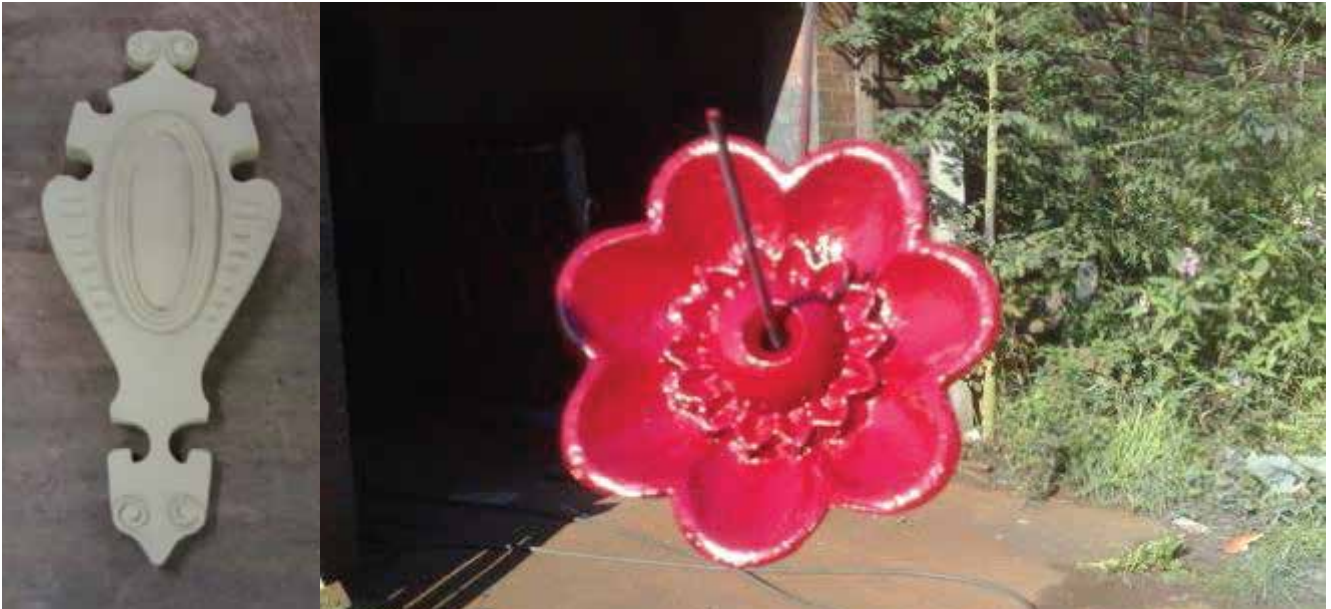
Following on from the zinc primer, an undercoat is applied, promoting both protection and adhesion of the top coats.

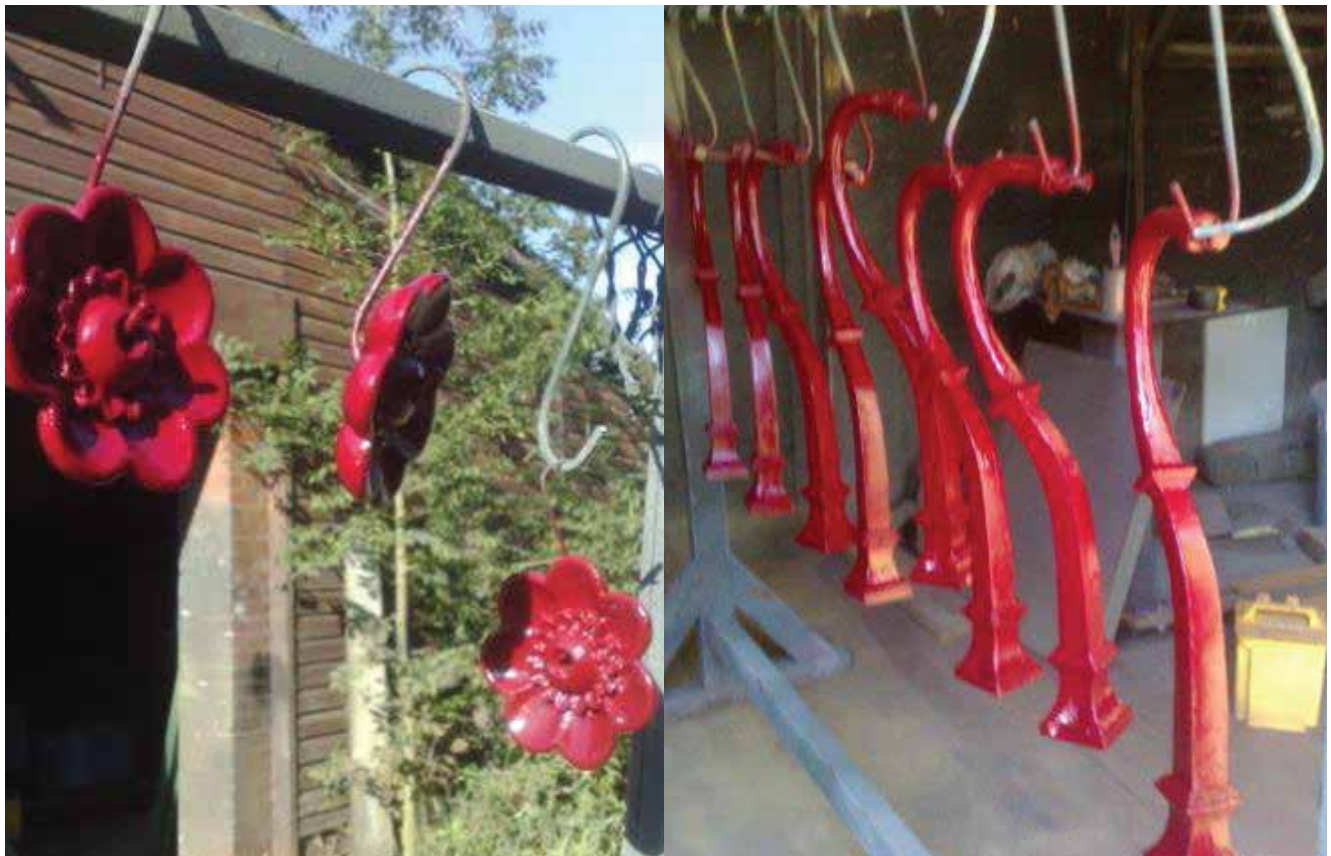
The top coats of paint are being applied in the historic paint scheme selected for the bandstand.

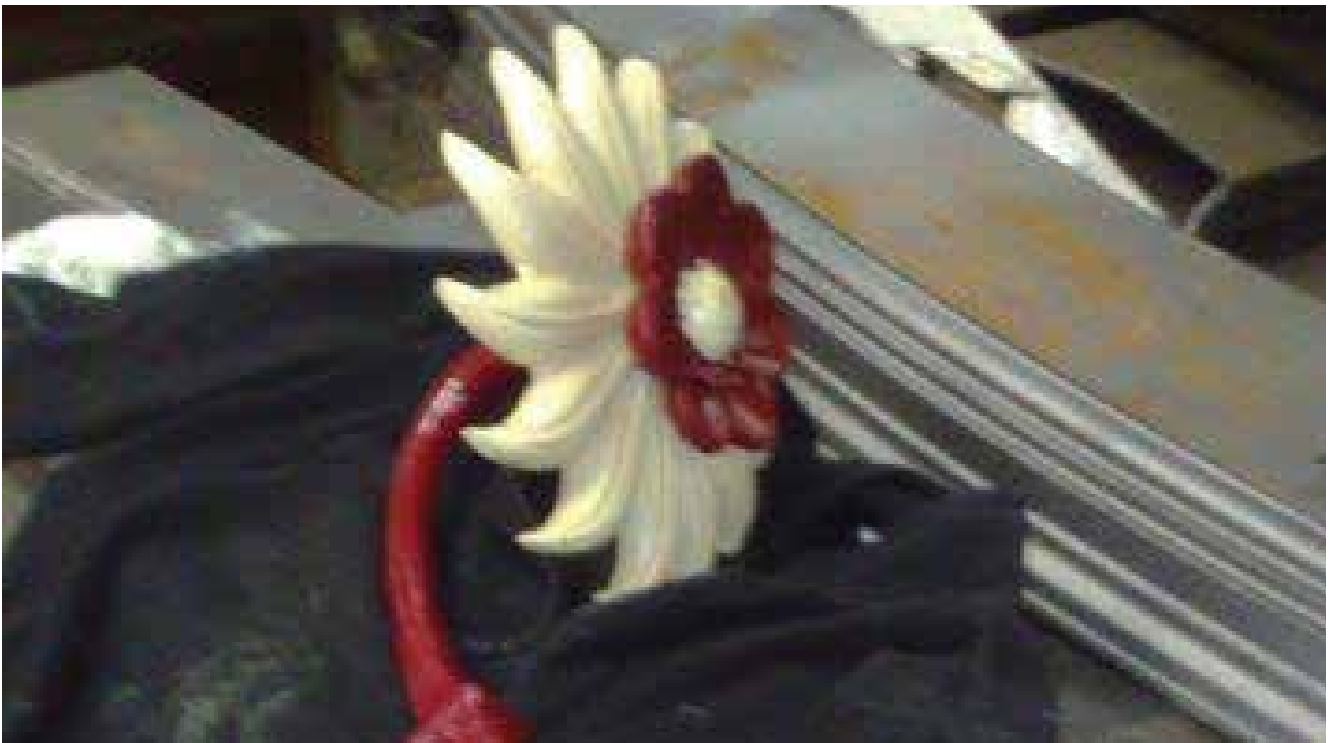
Once painted, components could be assembled and made ready for delivery to site when required for inclusion in the bandstand itself.

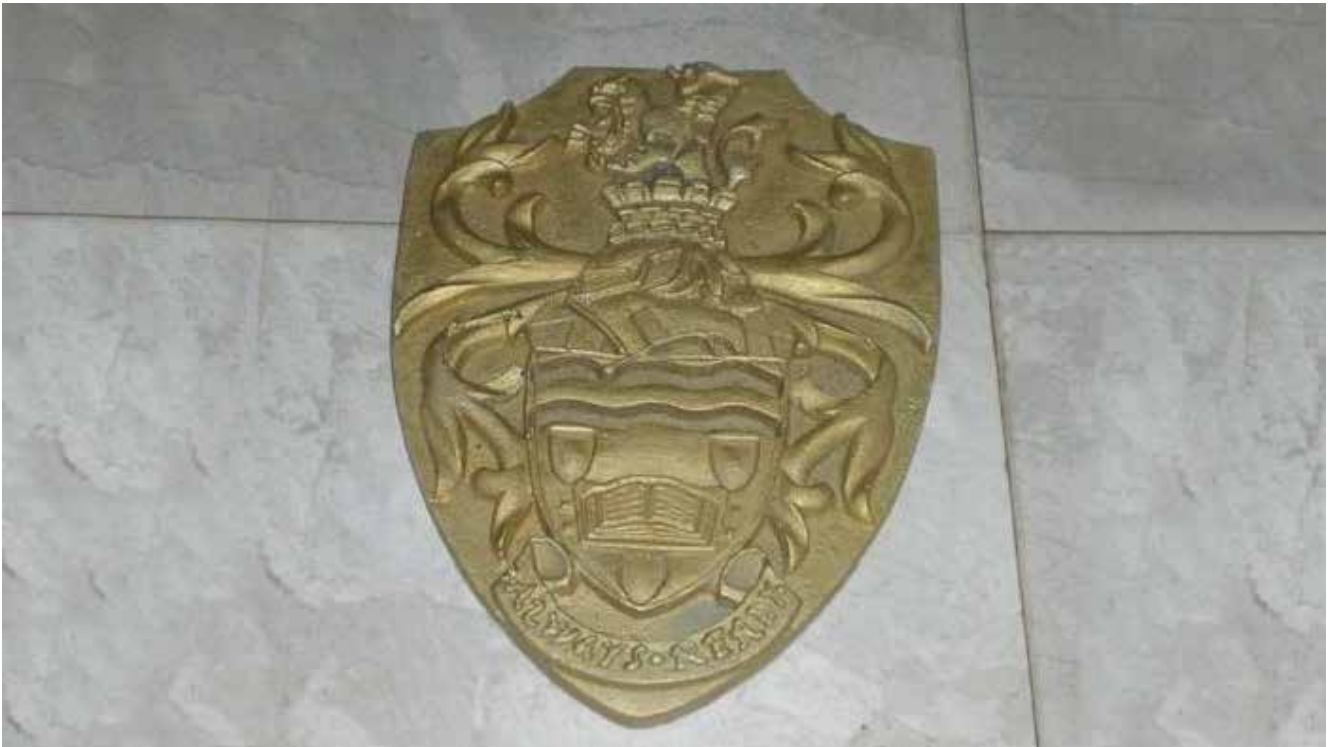
The South Shields town crest was reproduced as a cast iron panel, having first been wood carved, this would then be sent for decorative painting in order to highlight the detail of the shield.

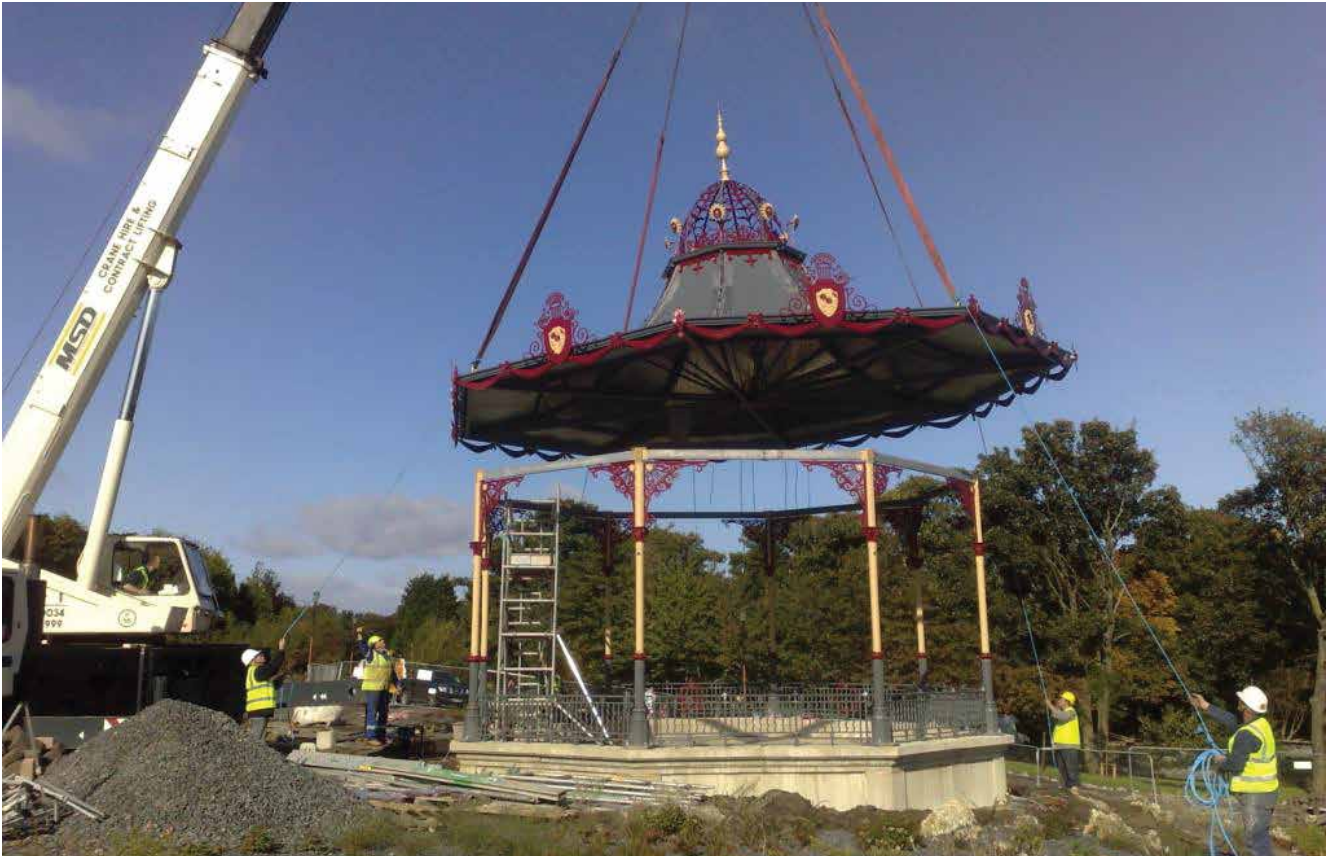
With the use of an even larger crane, things really started to move.

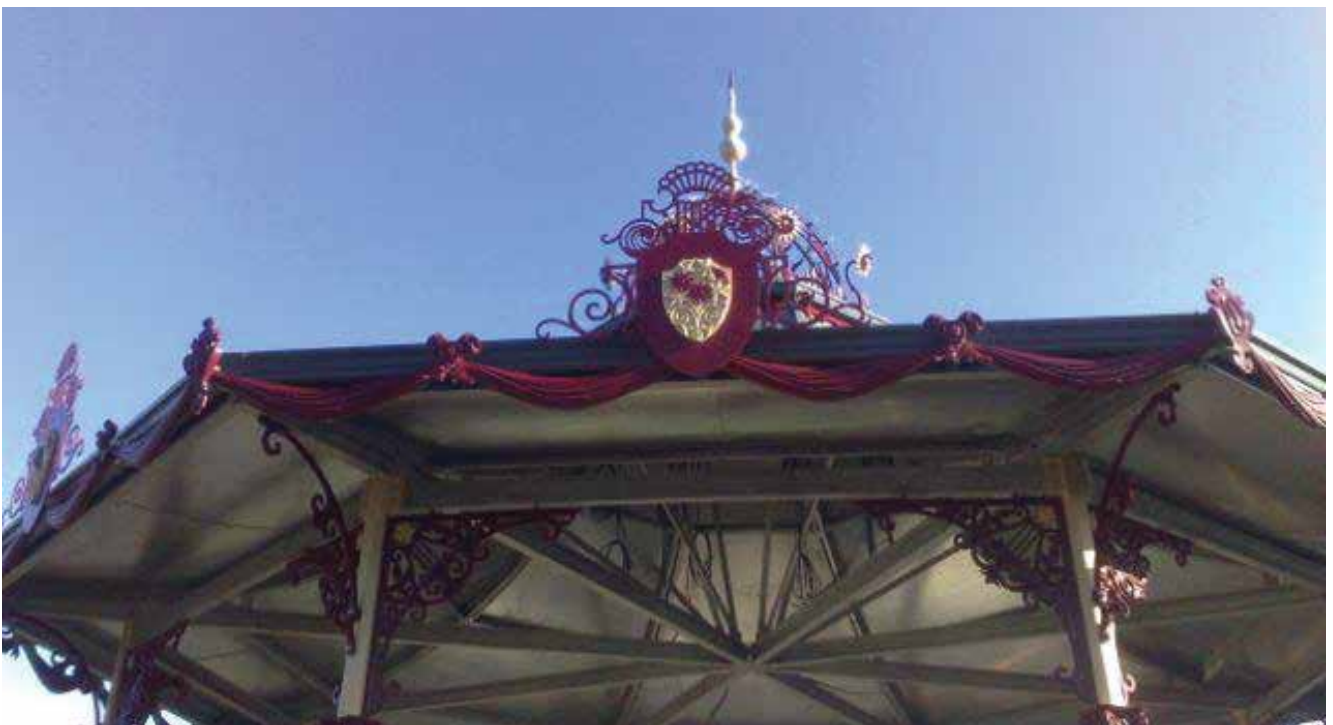
Until finally it all came together.

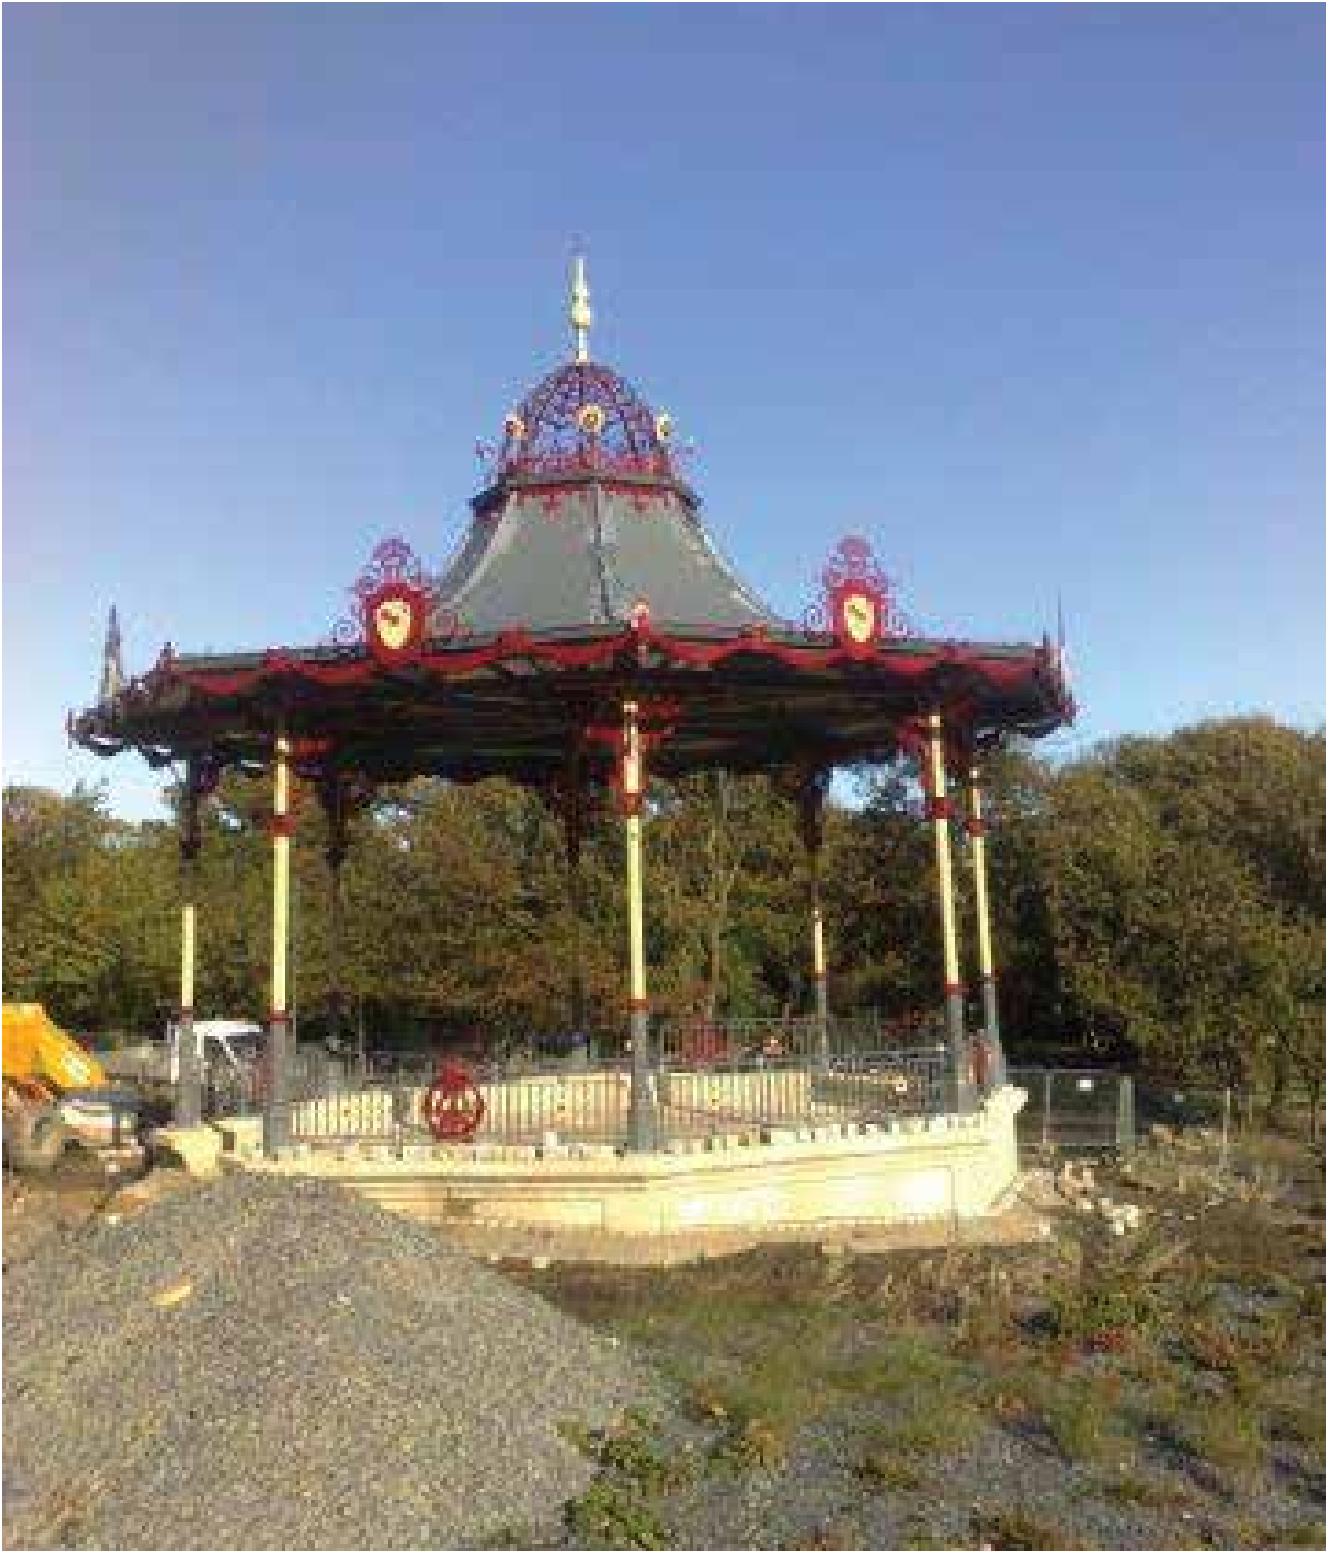
Just waiting for a clear up and then ready for a band.

Since these photographs were taken, more clearing of the site has taken place, the wooden roof lining has been added and a little more decorative painting has been applied.
